Matamata Piako District Council

Geotechnical Assessment for Zoning Plan
Change

10 February 2016

GENZTAUC16120AA-AB

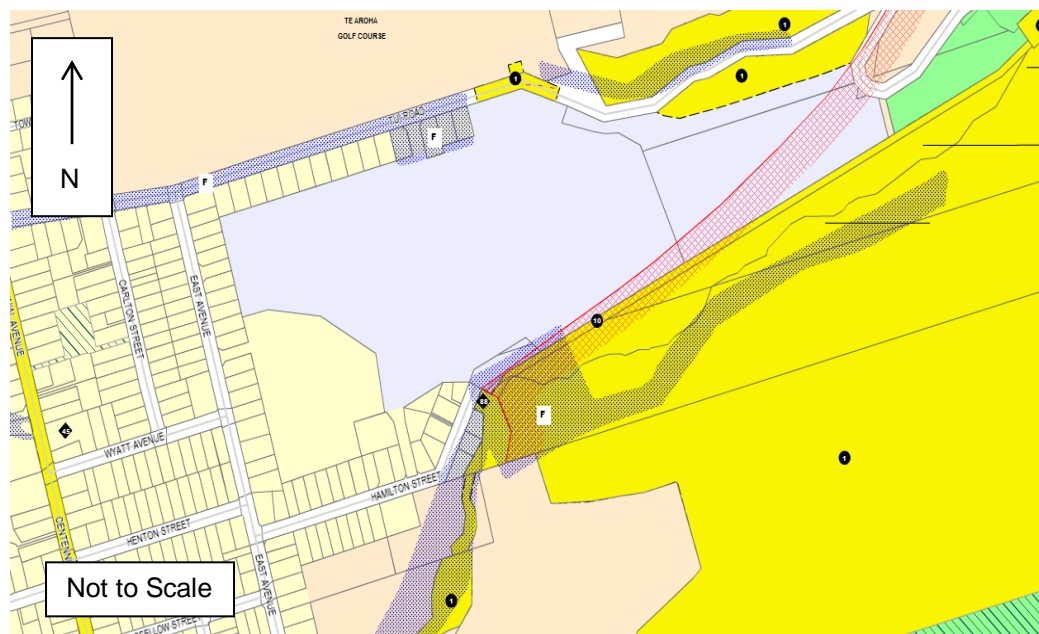
Figure 2: Council Zoning Map⁴

The site is currently designated on the GIS as 'Rural Residential' (refer to Figure 2), and is generally surrounded by 'Residential' land to the north, west and south. Sections of the site have also been designated as a 'Flood Hazard', and a 'Fire Hazard Buffer' extends along the southern edge of the site. To the east of the site, the land has been designated as 'Water and Soil Conservation', and 'Water Supply Catchment and Pipeline'. An historic building, the Te Aroha Power House, is situated at the end of Hamilton Street at the southern edge of the site.

The site is generally not designated as a flood hazard on the council GIS (refer to Figure 2), excluding some minor areas at the northern and southern fringes of the site. Additionally, the site is not shown to be within the River flood hazard zone on the Waikato Regional Council Flood Hazard map¹³

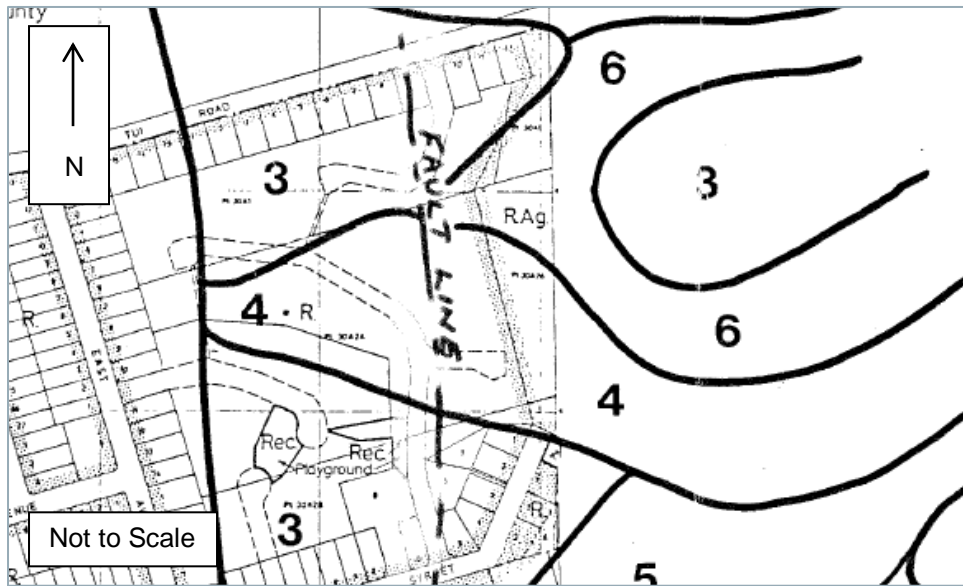
Figure 3: Flood Hazard Survey Map

The survey indicates that the lower, western section of the site generally lies within hazard zone 3, with a section running east-west through the site defined as hazard zone 4. The raised eastern section of the site generally lies within hazard zone 3, with a curve-shaped section beneath identified as hazard zone 6 (refer to Figure 3).

These ratings indicate that the western section of the site is generally at a slight risk of inundation from floodwaters (zone 3), but also contains land within the general floodplain of a tributary stream coming off the hillslope to the east (zone 4). Under peak flooding within these zones, the streams are expected to be contained within their existing stream bed locations. However, if a landslide was to occur from the hills to the east of the site and temporarily dam the stream, widespread flood damage could be expected within this section of the site when the temporary dam is breached. Debris flow is known to have impacted Te Aroha during the flood of 1985, although it is unknown if the site was impacted.

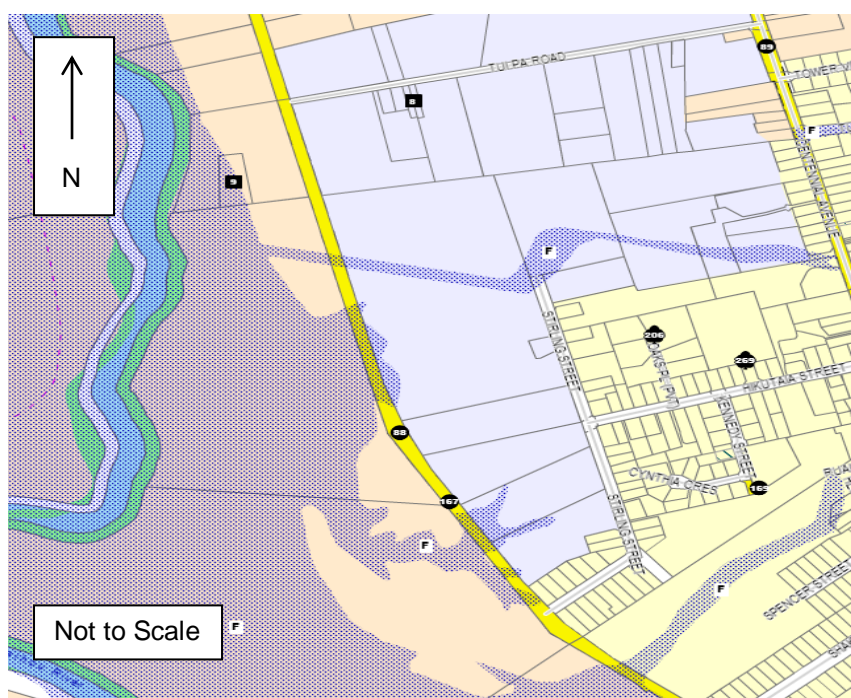
Figure 5: Council Zoning Map¹⁶

Sections of the site have also been designated as a 'Flood Hazard' on the GIS, which appears to be associated with the floodplain of the Waihou River and local streams.

The site has some flood hazard areas on the council GIS (refer to Figure 5) towards the western edge of the site, and a stream flowing east-west through the northern section of the site. The Waikato Regional Council Flood Hazard map²⁰ also indicates that western edge of the site is designated as a flood hazard. As such, we recommend that specific flood considerations should be made for future development consents.

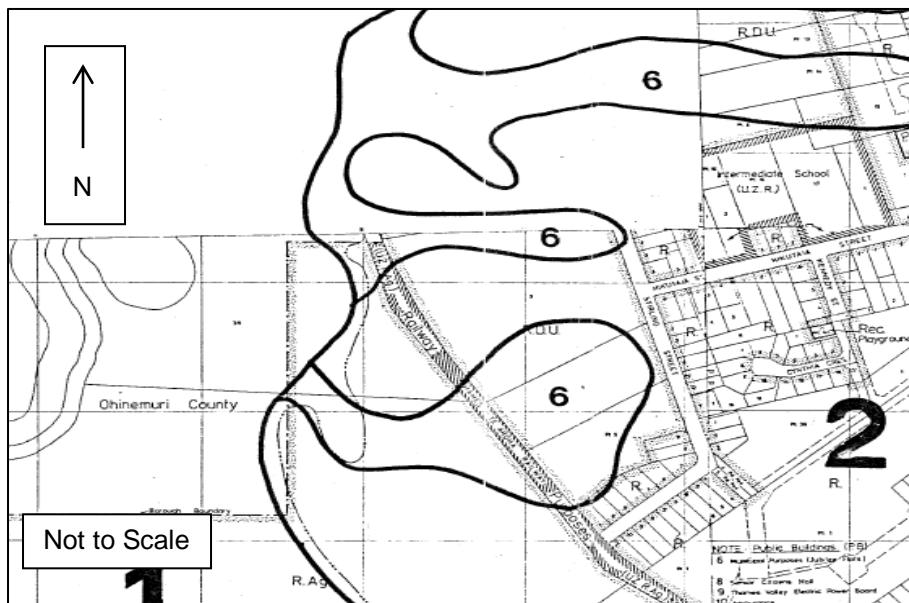
Figure 6: Flood Hazard Survey Map

The survey indicates that the site generally lies within hazard zone 2, with sections of the western side of the site defined as hazard zone 6 (refer to Figure 6). The area to the west of the site, near the Waihou River, is defined as hazard zone 1.

These ratings indicate that the site is gently sloping and generally above the level of likely flooding (zone 2). However, there are areas of the site situated within the flood plains of tributary streams flowing from the mountains to the east (zone 6). Within these areas, there could be the potential for structural damage to buildings where a high rainfall intensity results in the overtopping of the streams. In the event where slope instability results in the temporary containment of the stream, the widespread flood damage could be expected across the site when the temporary dam is breached. The land immediately west of the site (zone 1) is essentially flat land of the Hauraki Plains and is within the floodplain of the Waihou River.

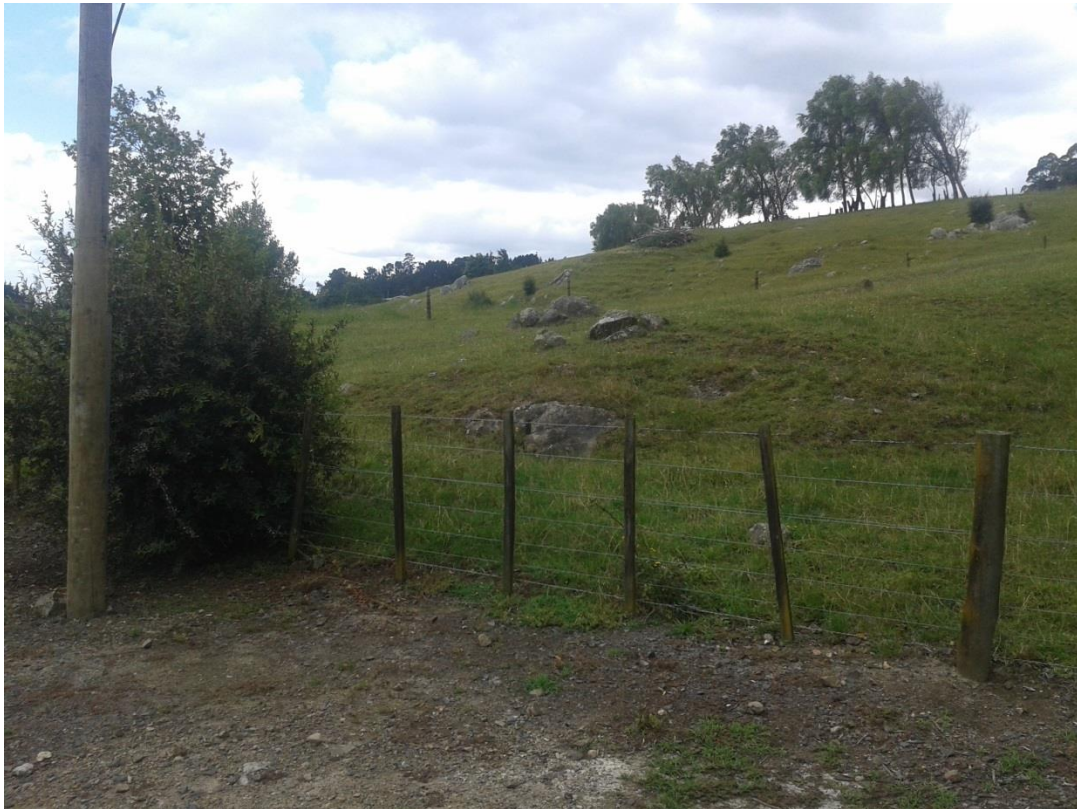
Evidence of past land instability was observed during the site visit, as well as on topographical maps. This includes boulders scattered across the site (refer to Appendix A), and a relatively steep, curved feature towards the east of the site. Aerial and topographical images also show similar features across the western foothills of the Kaimai Ranges, nearby to the site.

Photograph 3: Boulders at Site 1 from Hamilton Street, looking north

Given the presence of relatively steep slopes on and near the site, we recommend that a detailed slope stability and debris flow analysis be undertaken prior to the development of the site. This would include an assessment of landslide debris potentially inundating the western section of the site.
