# GEOTECHNICAL ASSESSMENT REPORT

70 KENRICK STREET,  
TE AROHA

PROJECT NO: HD2771-1  
KENWYN TRUST  
REFERENCE: GAR-1  
18 OCTOBER 2023

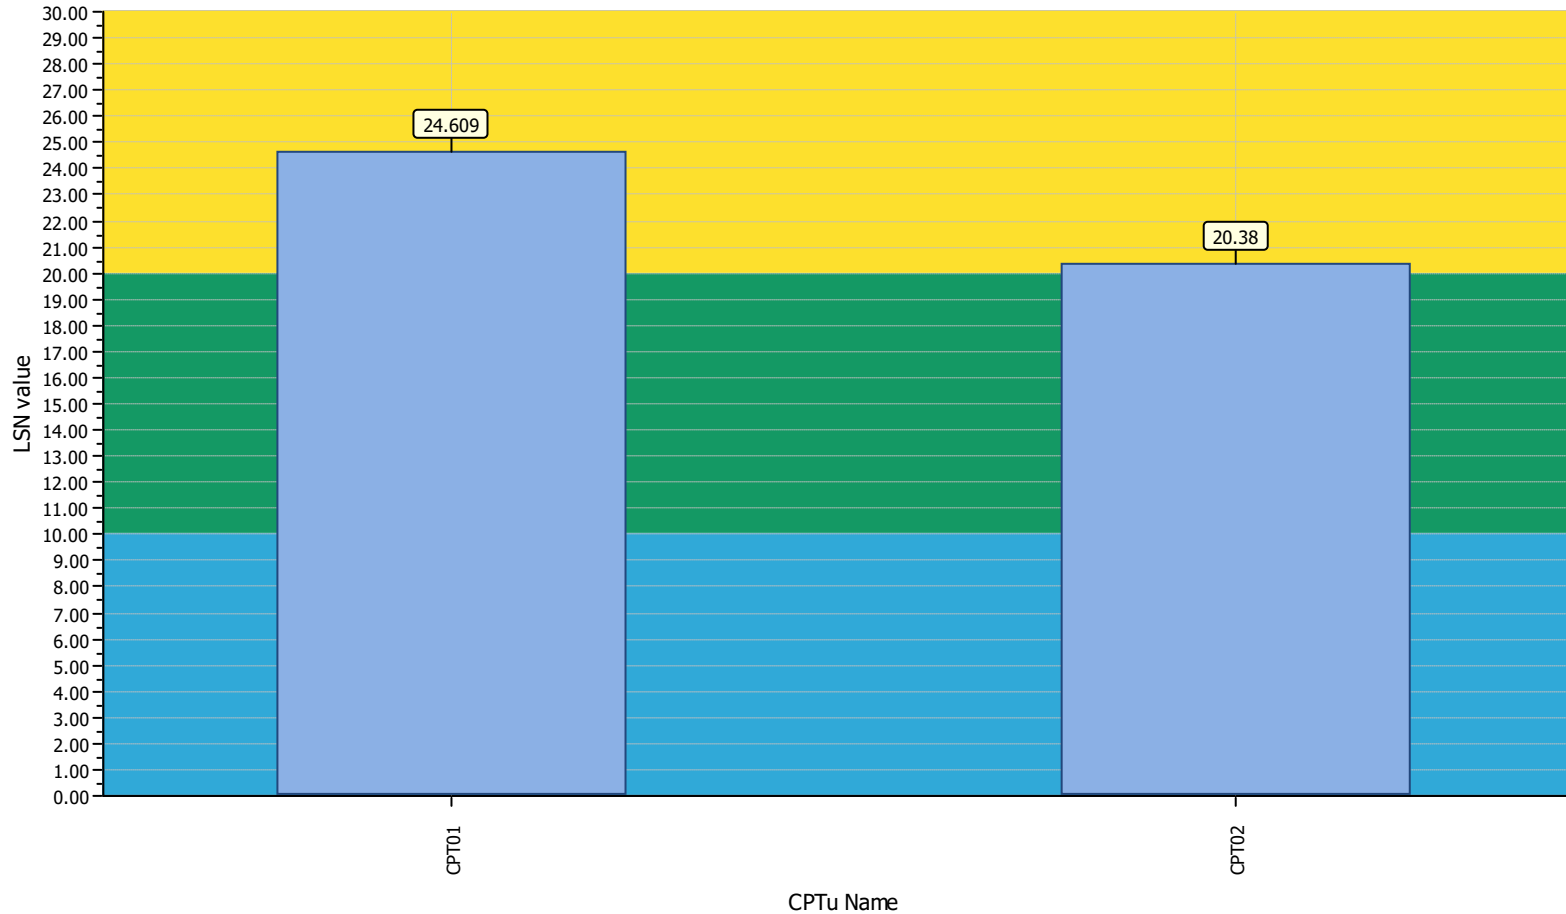
### Overall Liquefaction Severity Number report

- Total CPT number: 2
- 0% little liquefaction
- 0% minor liquefaction
- 100% moderate liquefaction
- 0% moderate to major liquefaction
- 0% major liquefaction
- 0% severe liquefaction

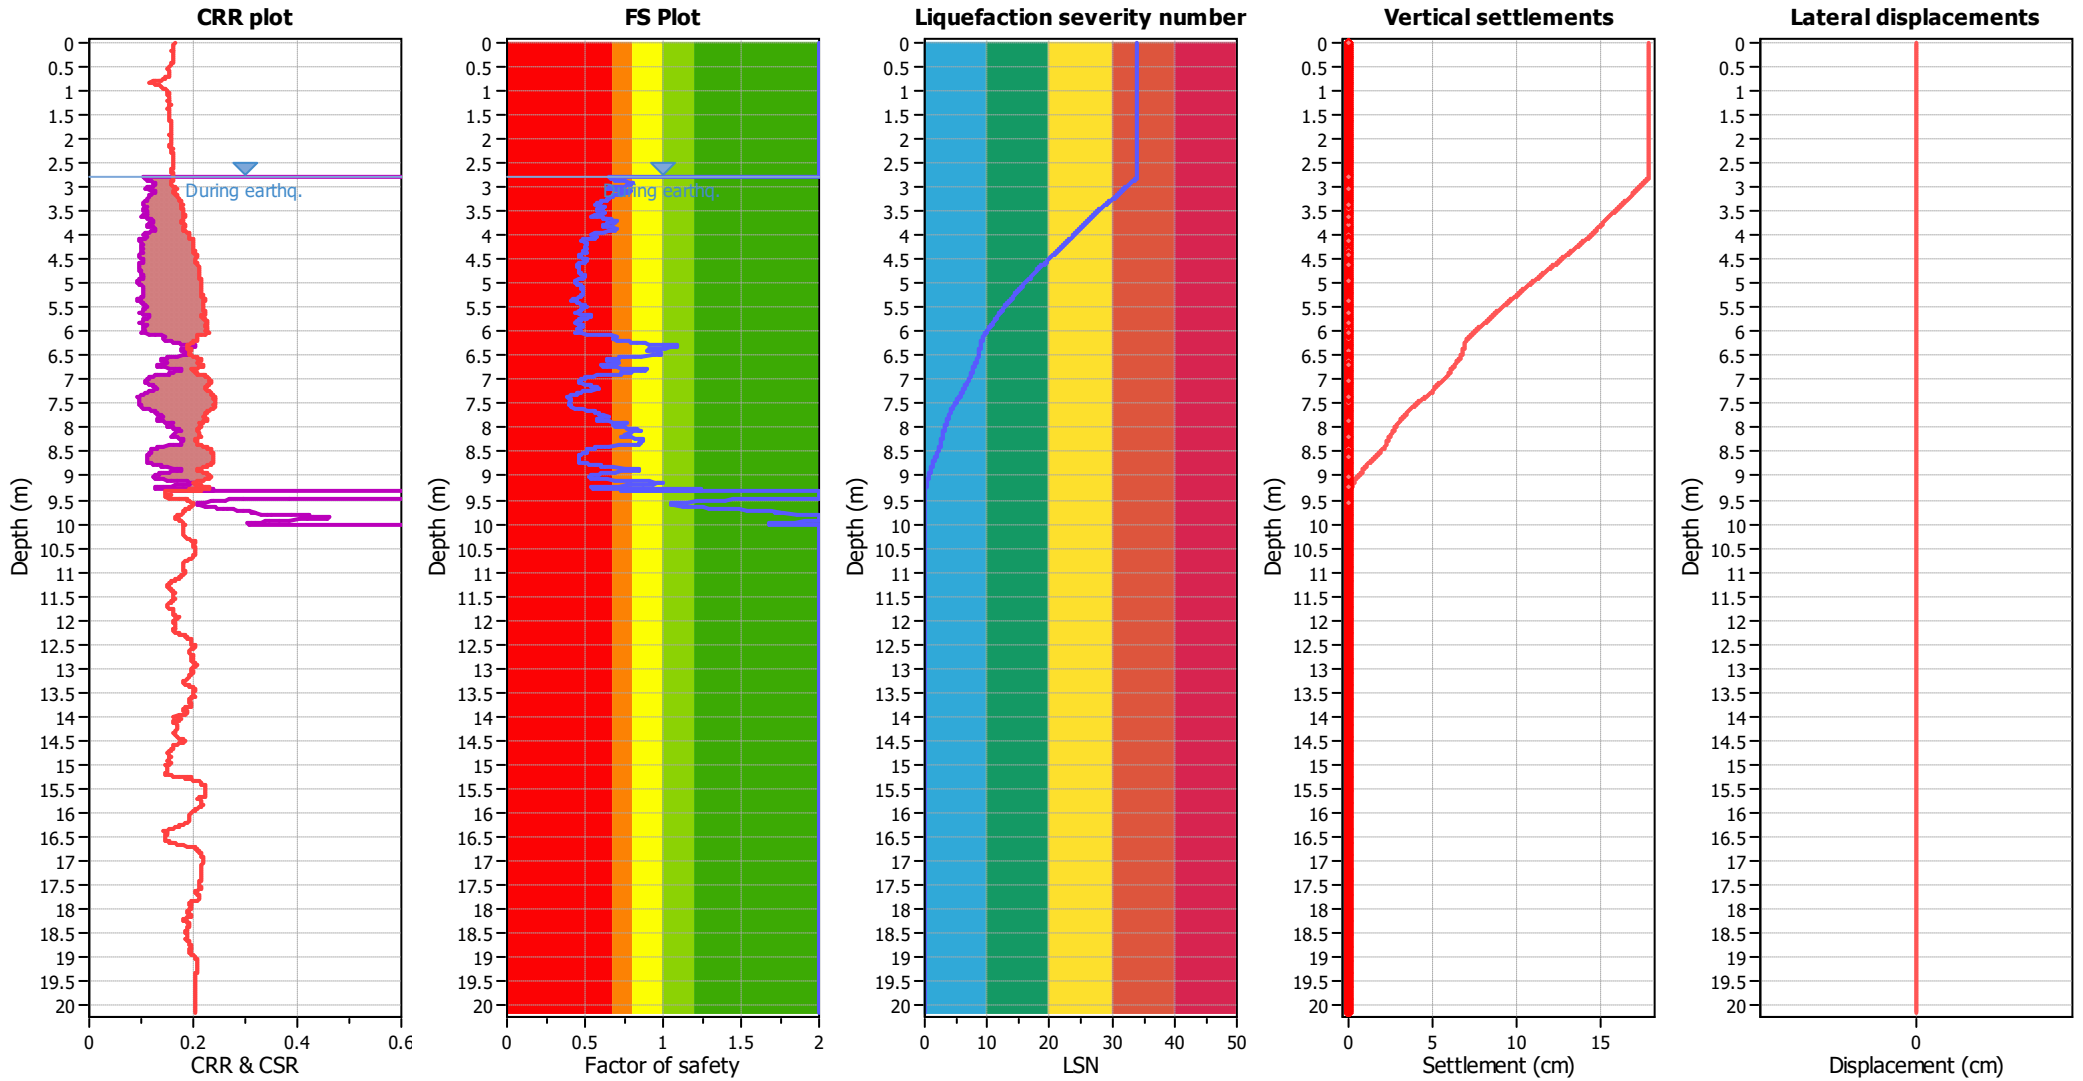
### Liquefaction analysis overall plots

**Input parameters and analysis data**

| Analysis method: | B&I (2014) | Depth to GWT (earthq.): | 2.80 m | Fill weight: | N/A |

We have assessed the site with the encountered groundwater conditions. To understand the overall liquefaction risk, we have completed a sensitivity analysis on the groundwater conditions and assumed a peak high groundwater table of 1.0 m higher (between 2.8 m and 2.9 m below ground level).

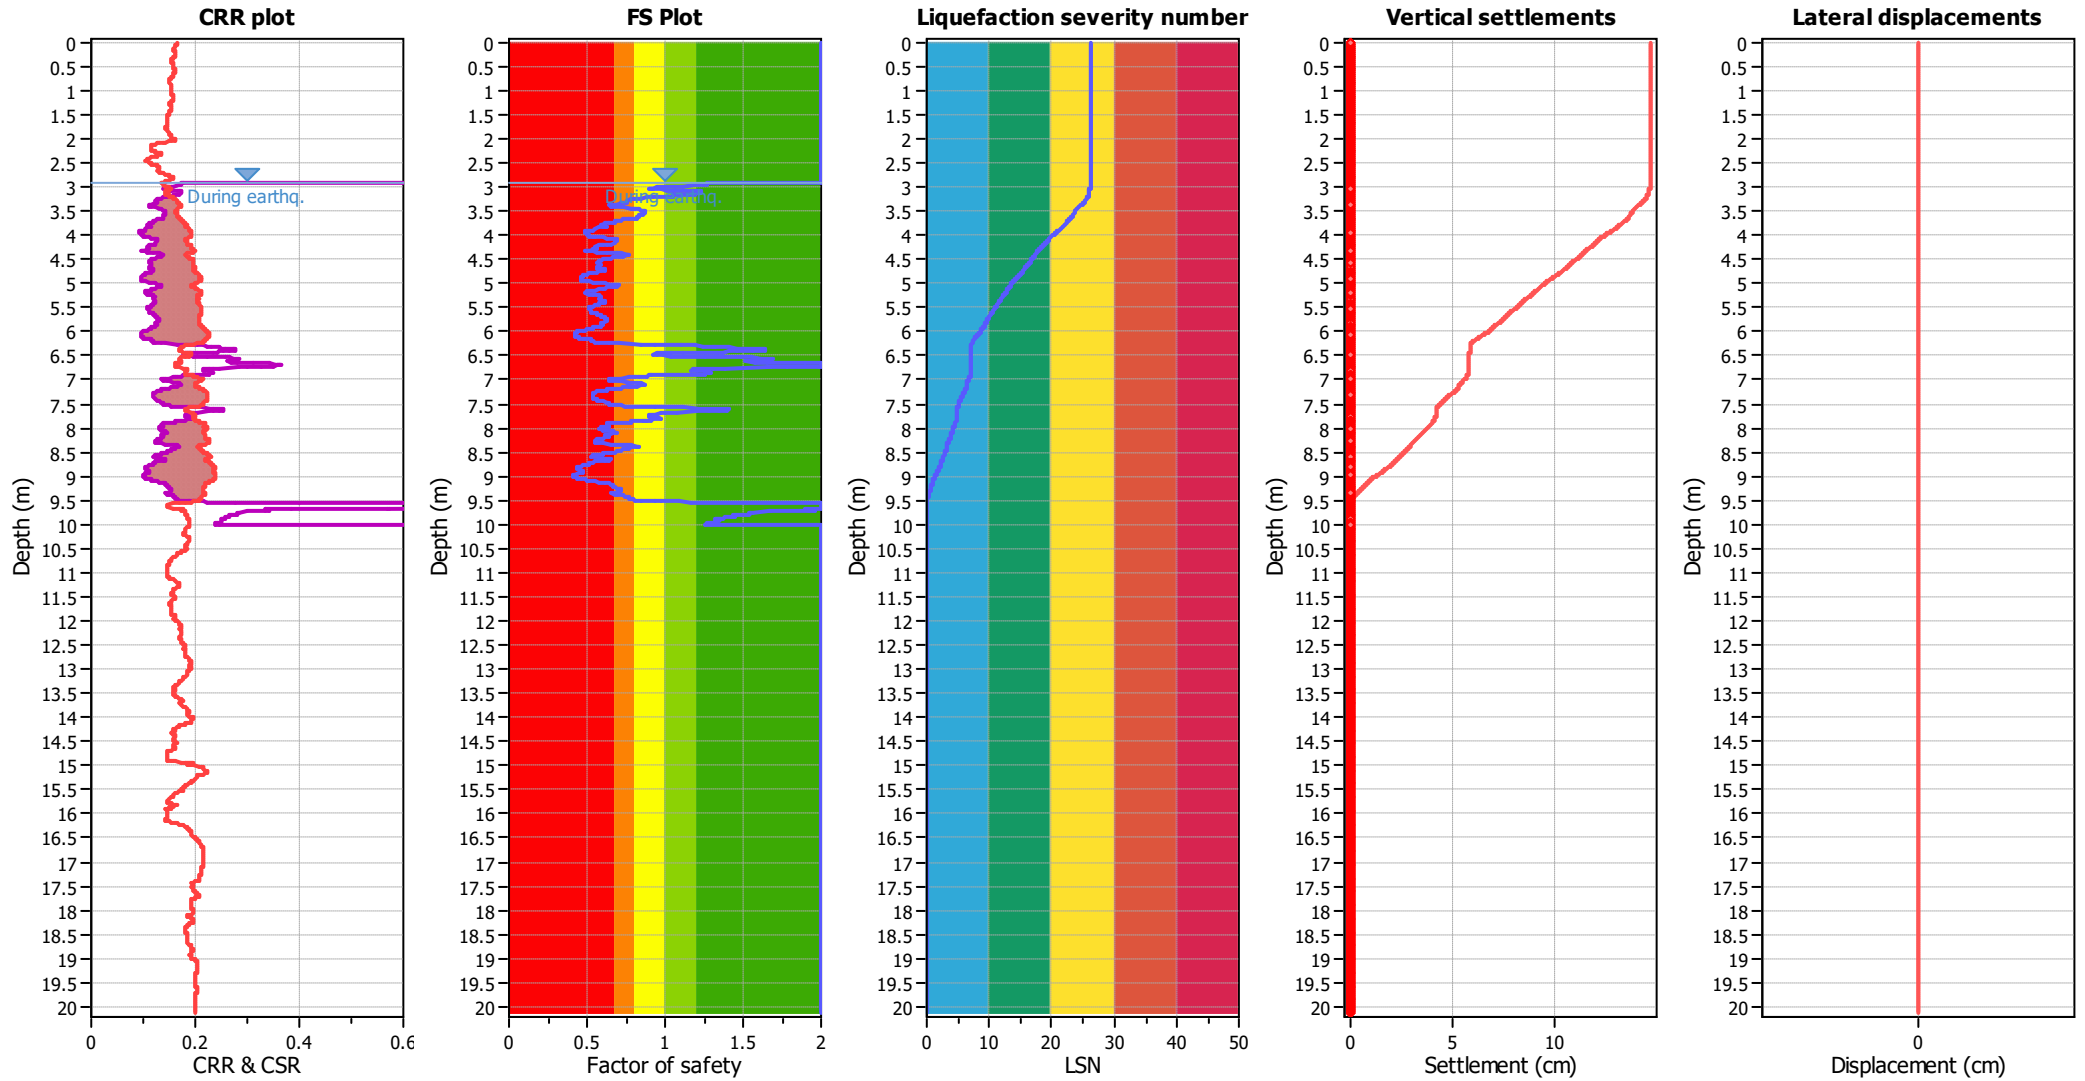
### Liquefaction analysis overall plots

**Input parameters and analysis data**

| Analysis method: | B&I (2014) | Depth to GWT (earthq.): | 2.90 m | Fill weight: | N/A |

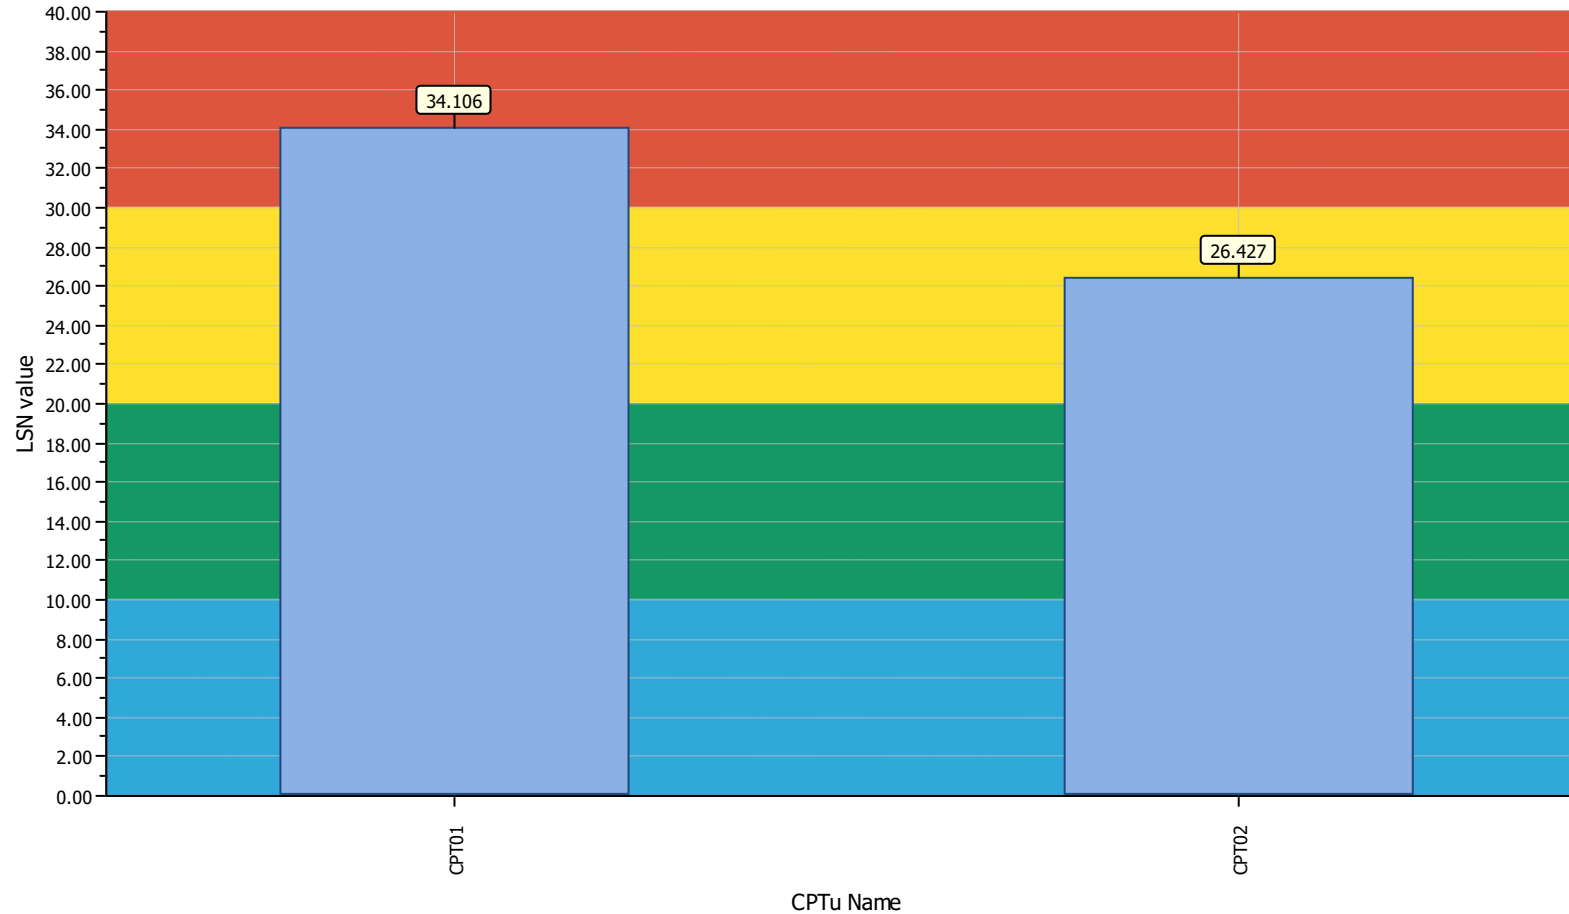
### Overall Liquefaction Severity Number report

- Total CPT number: 2
- 0% little liquefaction
- 0% minor liquefaction
- 50% moderate liquefaction
- 50% moderate to major liquefaction
- 0% major liquefaction
- 0% severe liquefaction

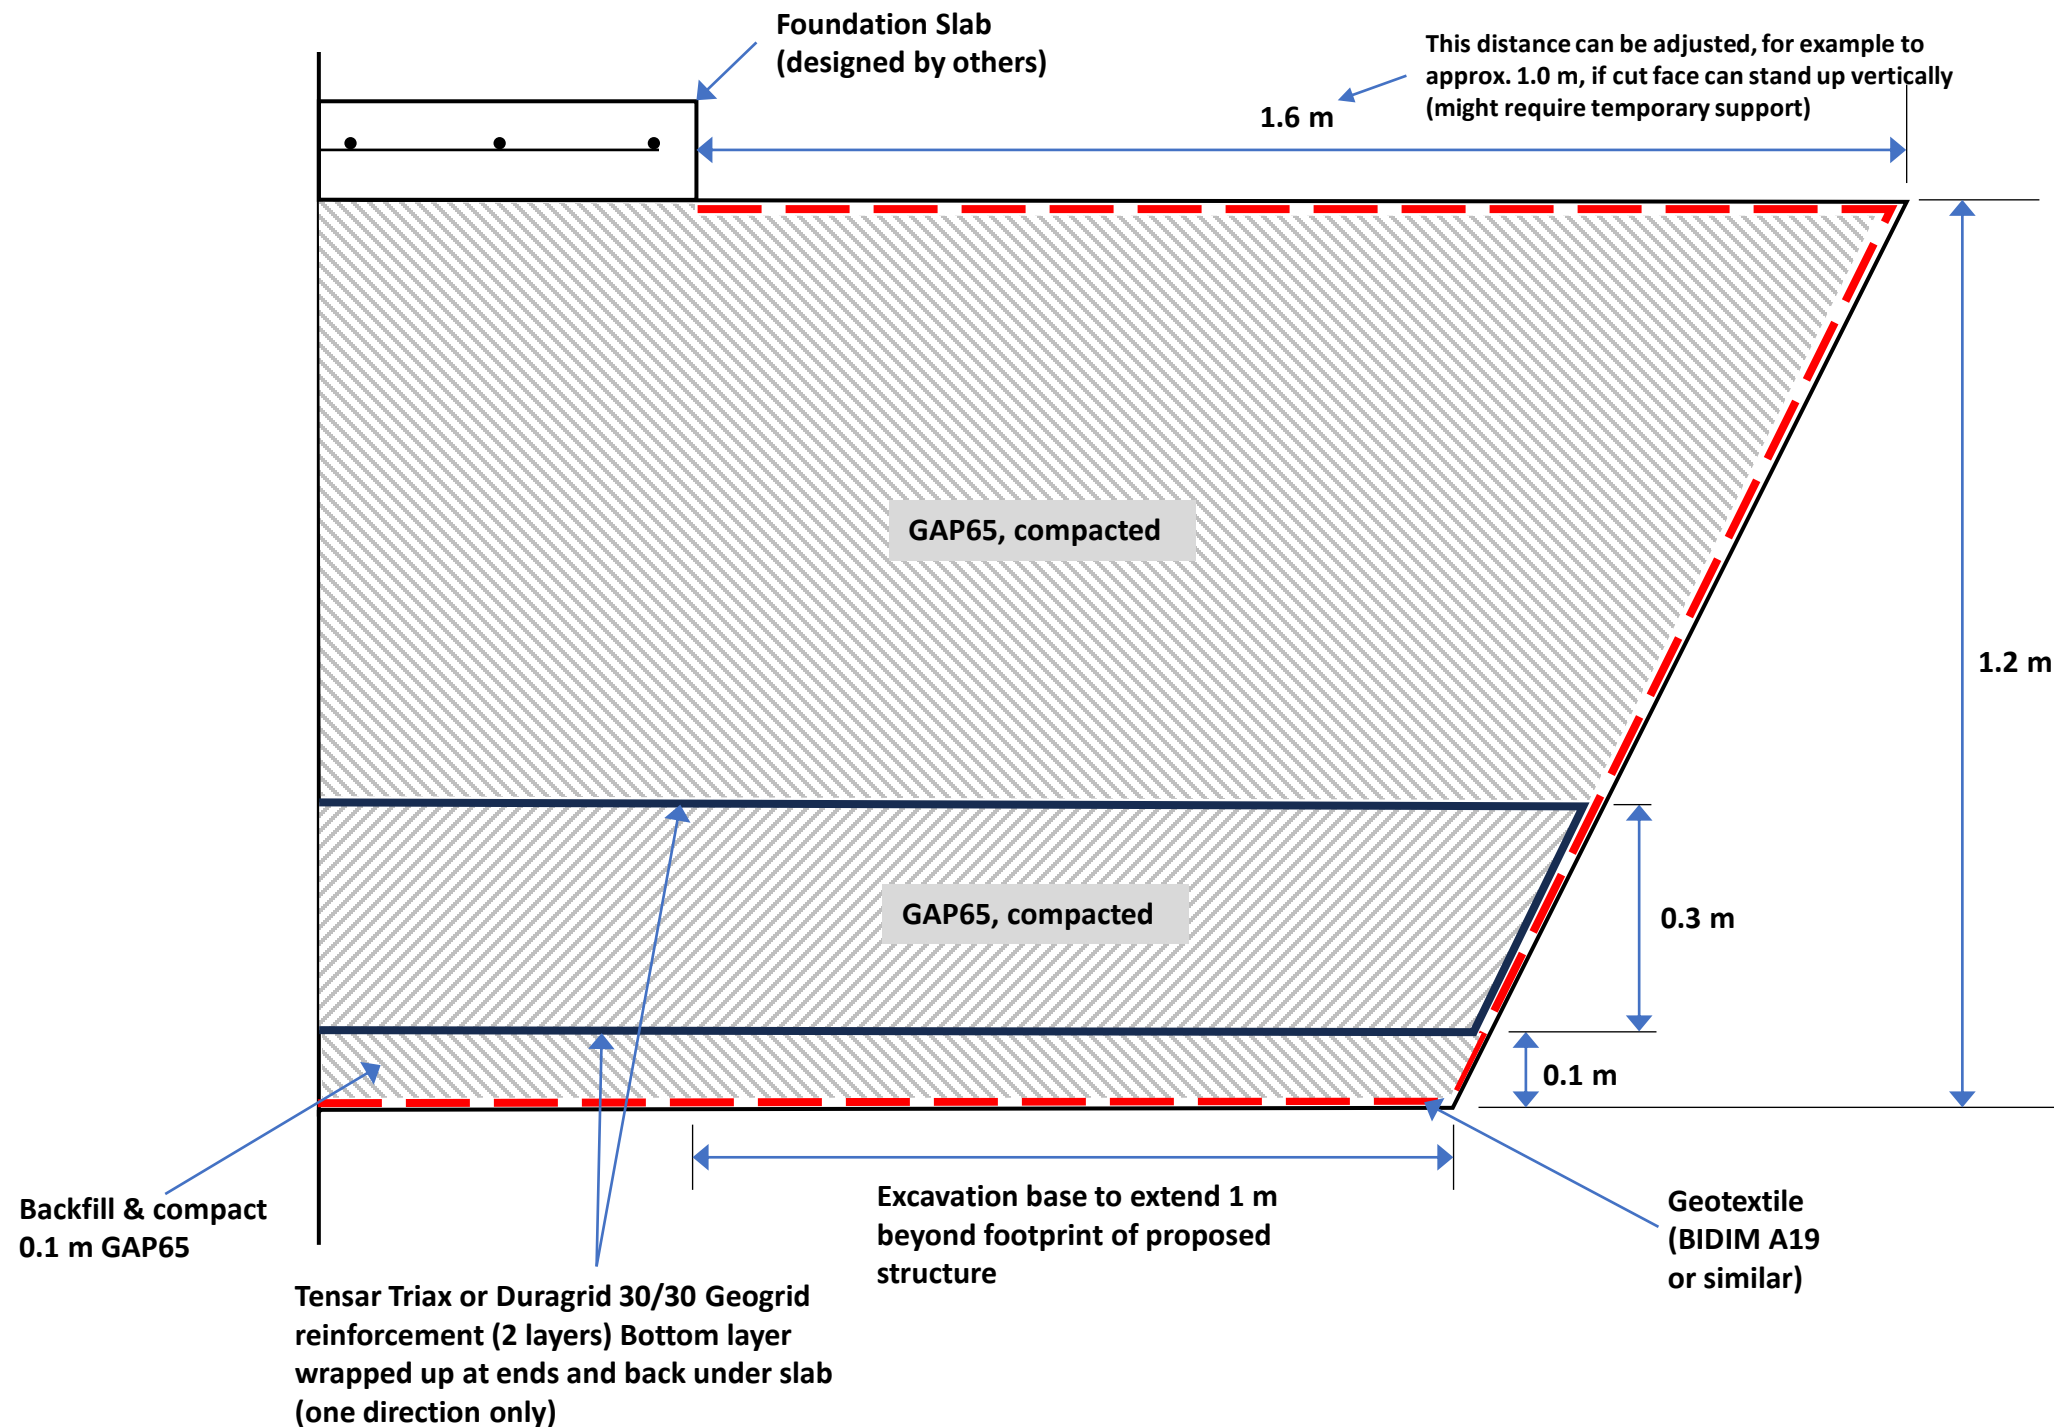
# APPENDIX D – RAFT FOUNDATION DETAIL

**Excavation and Soil Remediation Methodology:**

1. Excavate and remove all existing loose soils (approximately 1.2 m) until undisturbed natural soils are exposed. A minimum depth of 1.0 m below the underside of foundation beams is required. A minimum width of 1.6 m beyond the outside edge of the building foundation is required.
2. Line base of excavation with geotextile filter fabric (BIDIM A19 or similar approved).
3. Backfill and compact 0.1m of hardfill (GAP65 or similar).
4. Place one layer of geogrid reinforcement (Tensor Triax, Duragrid 30/30 or approved equivalent) at 0.1 m above the base of the excavation and a second layer at 0.4 m above the base of the excavation, placing compacted hardfill in 150 mm layers between the grids.
5. All detailed compaction requirements and testing to be completed in accordance with the geotechnical engineer's specifications and approval.

The use of shallow ground improvement (minimum 1.2 m deep), consisting of a geogrid reinforced hardfill raft, followed by a TC2 type stiffened concrete ribraft or waffle slab foundation will be suitable for the site.
