**Stirling Street, Te Aroha**

Stirling Street, Te Aroha - Assessment Report

1 June 2017

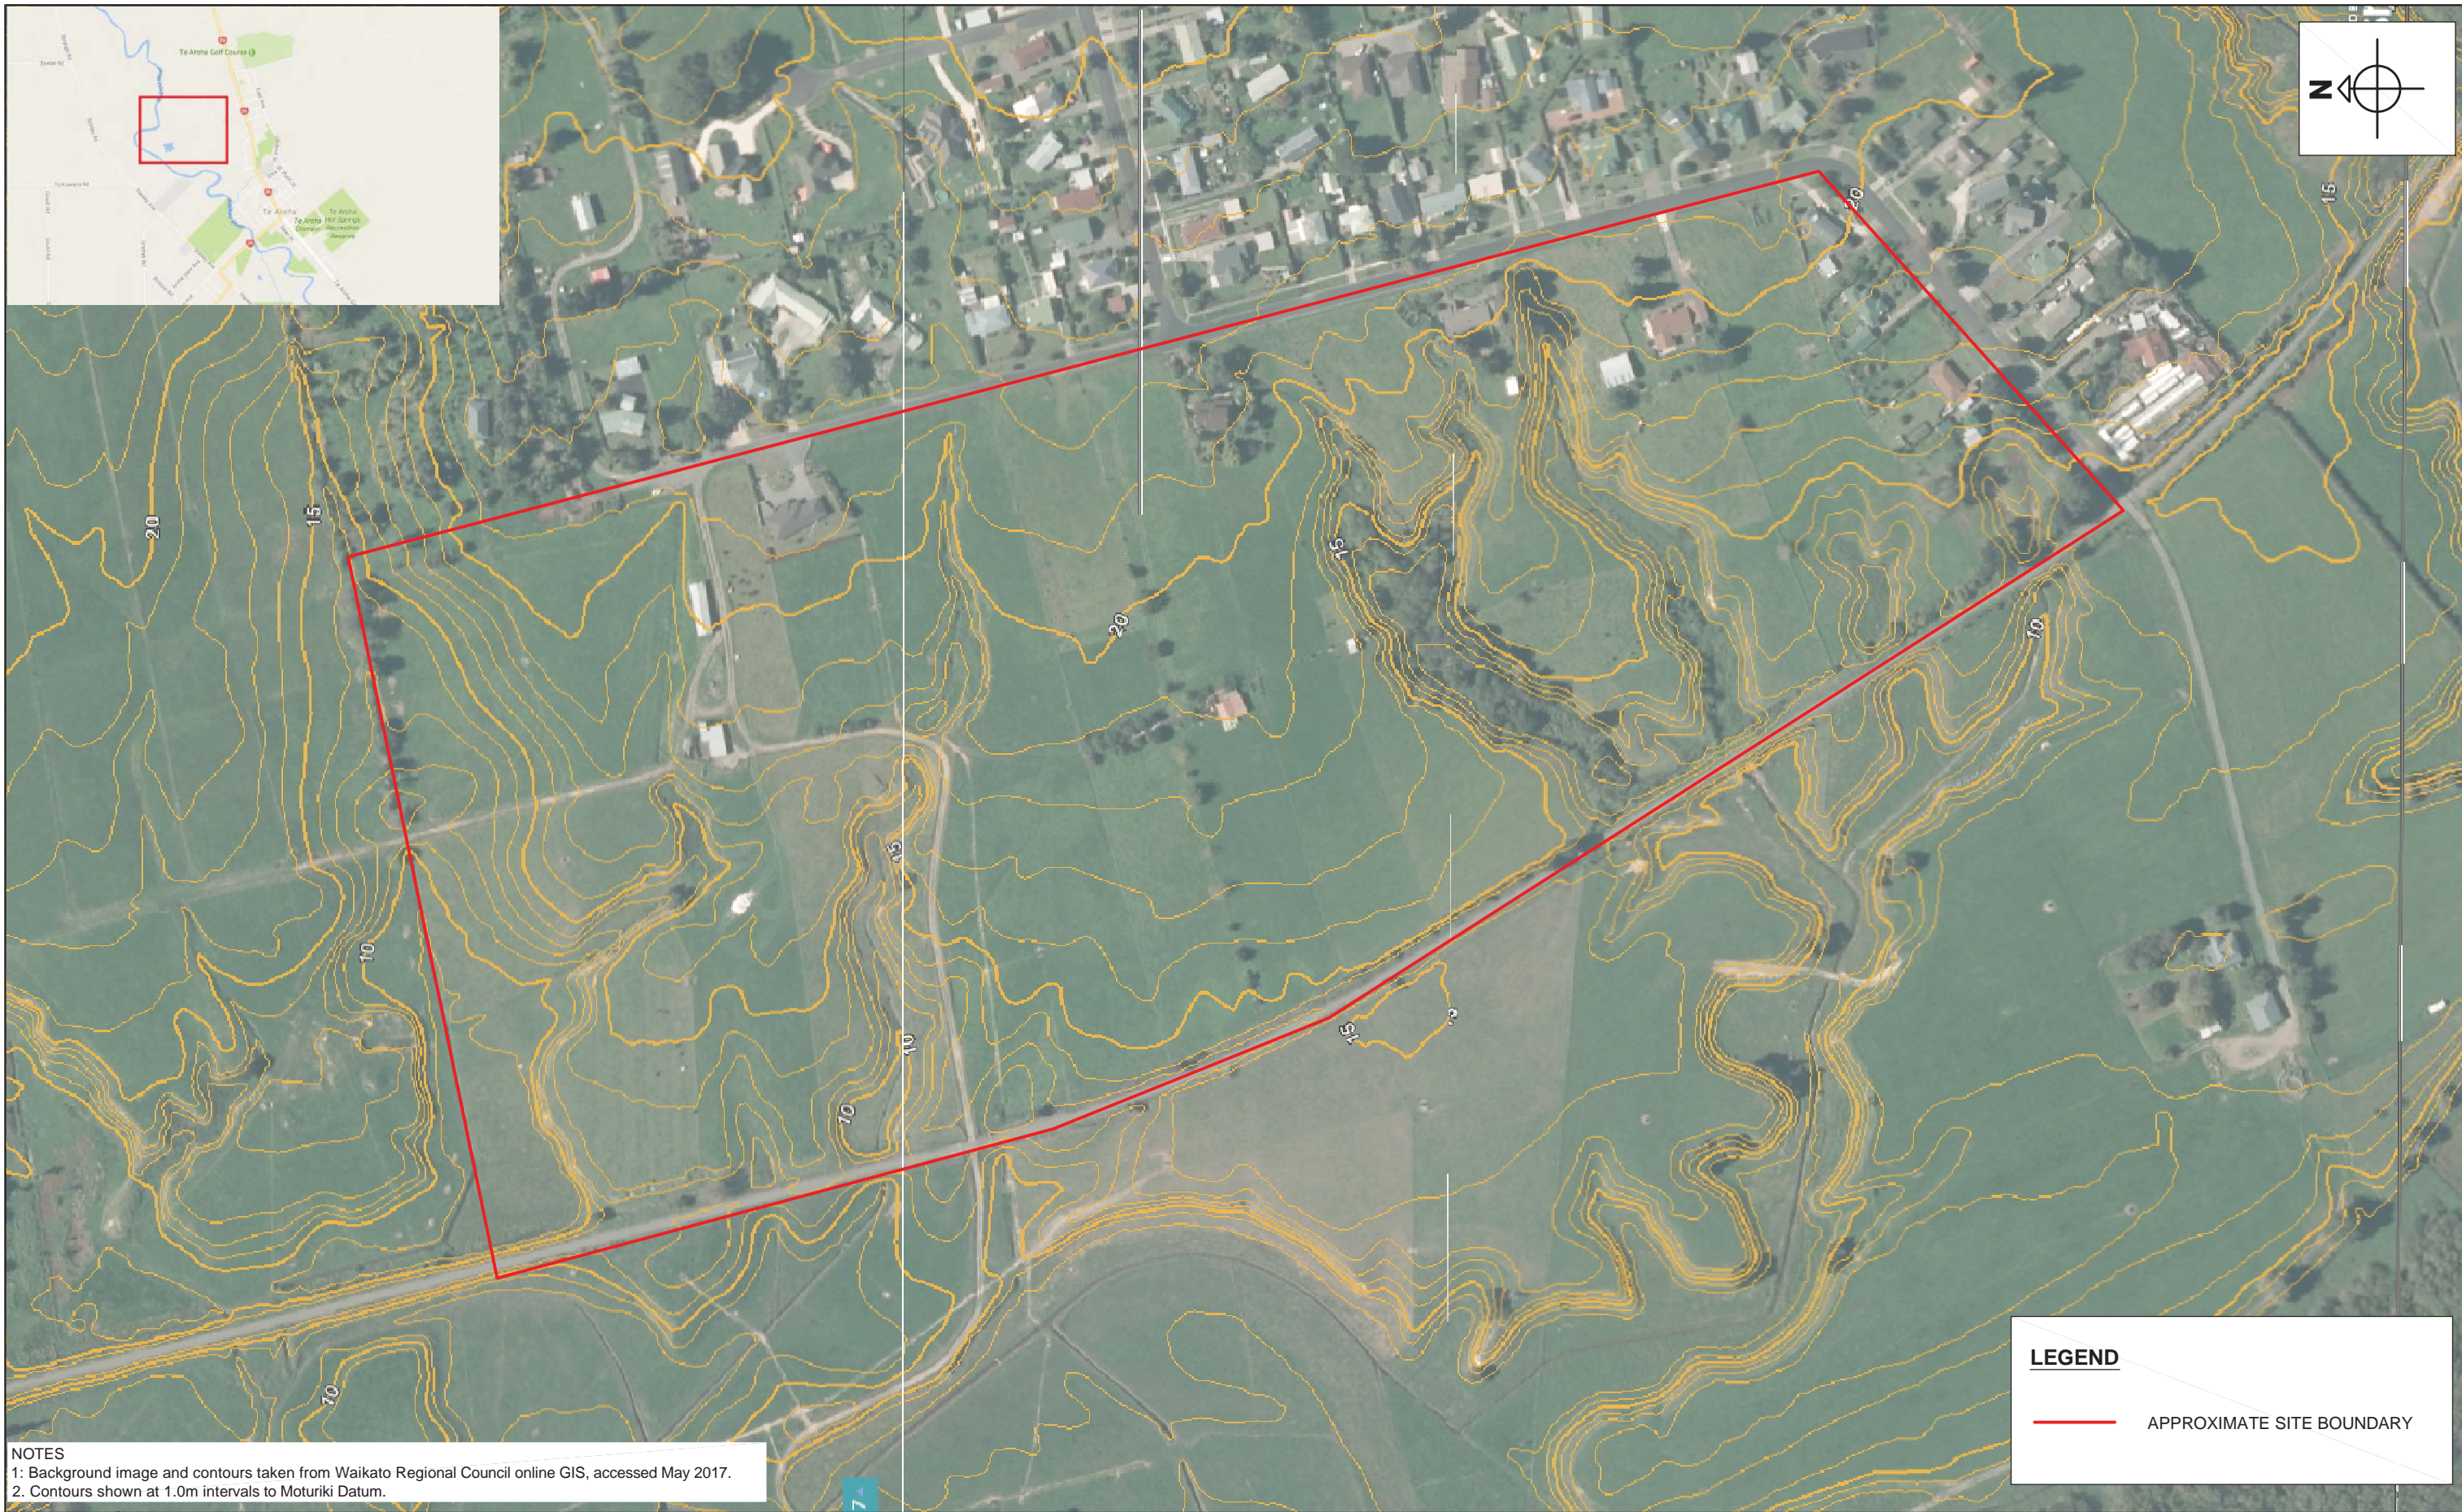
client:	MATAMATA PIAKO DISTRICT COUNCIL		
project:	DESKTOP STUDY ASSESSMENT STIRLING STREET TE AROHA		
title:	SITE PLAN		
project no:	GENZTAUC16120AB	figure no:	01
rev:	0

The location of the site is shown on the Site Plan in Appendix A.

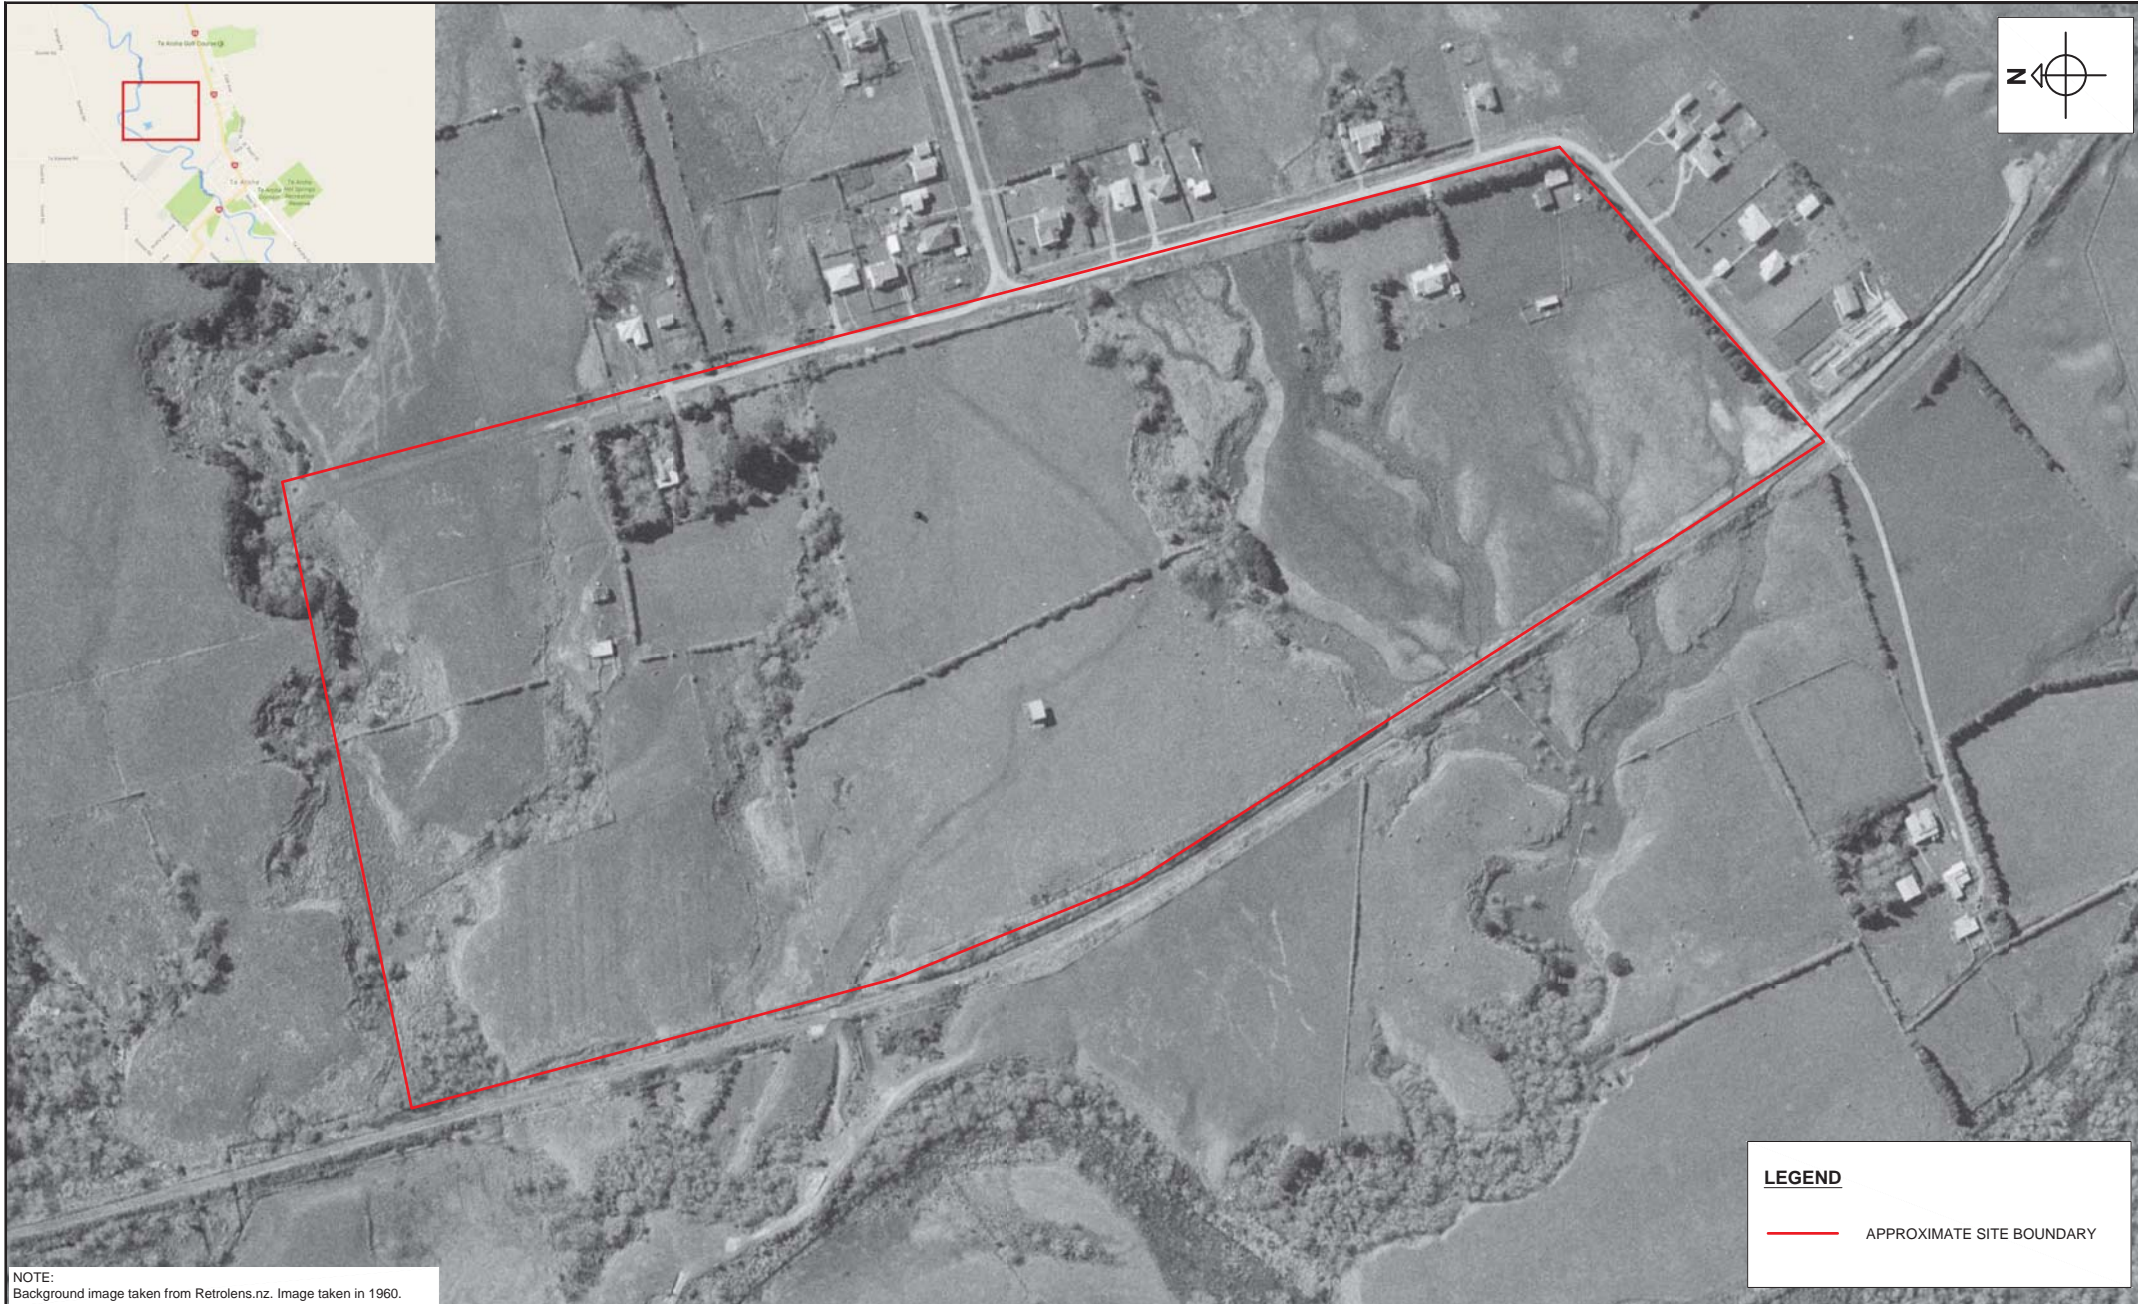
NOTE:  
Background image taken from Retrolens.nz. Image taken in 1960.

Historical aerial photographs<sup>6</sup> and mapping<sup>7</sup> of Te Aroha indicate that there has been development along Stirling Street since at least 1943. An aerial photograph from 1960 (refer to Figure 2 in Appendix A) appears to show large areas of the southern portion of the site subject to overland, stormwater flow.

Geotechnical Zone 2 covers a plan area of approximately 3.8ha and generally comprises lower-lying, flat to moderately sloping areas, and areas of apparent, historic overland stormwater flow (as shown on the 1960 aerial photograph on Figure 2). Zone 2 is generally located towards the western side of the site, near the Waihou River floodplain. The ground surface in this zone typically grades at less than 1V:10H, although there are areas situated near steep gullies.
