Matamata-Piako District Council Track Strategy

Part 1 – Strategy

Adopted by Council July 2008

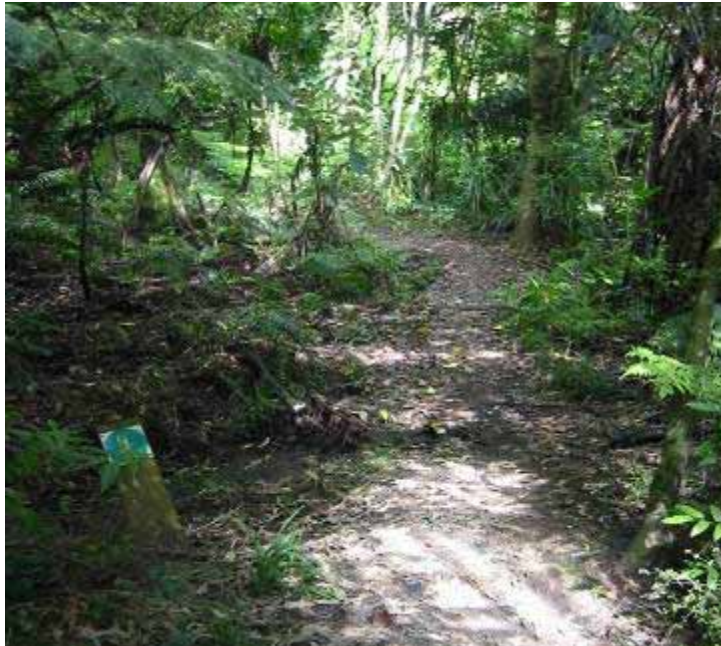
Figure 4: Te Aroha Domain Upper Walk

Te Aroha Domain Upper Walk	
CONDITION	EXISTING
Track Classification	Short Walk
Track Length	707 m
Width Average	.92 m
Grade Average	8.6%
Surface Type	Clay, Gravel
Surface Condition	Minor wear – poor with some problems
Drainage Type	Mono Sloped, Side Drain
Drainage Condition	Minor – poor with some problems
Signage Type	Directional
Signage Condition	Minor wear – poor with some problems
Barrier Type	n/a
Barrier Condition	n/a

This track passes by historic points of interest and is suitable for visitors to the Te Aroha Domain wanting a short bush walk.

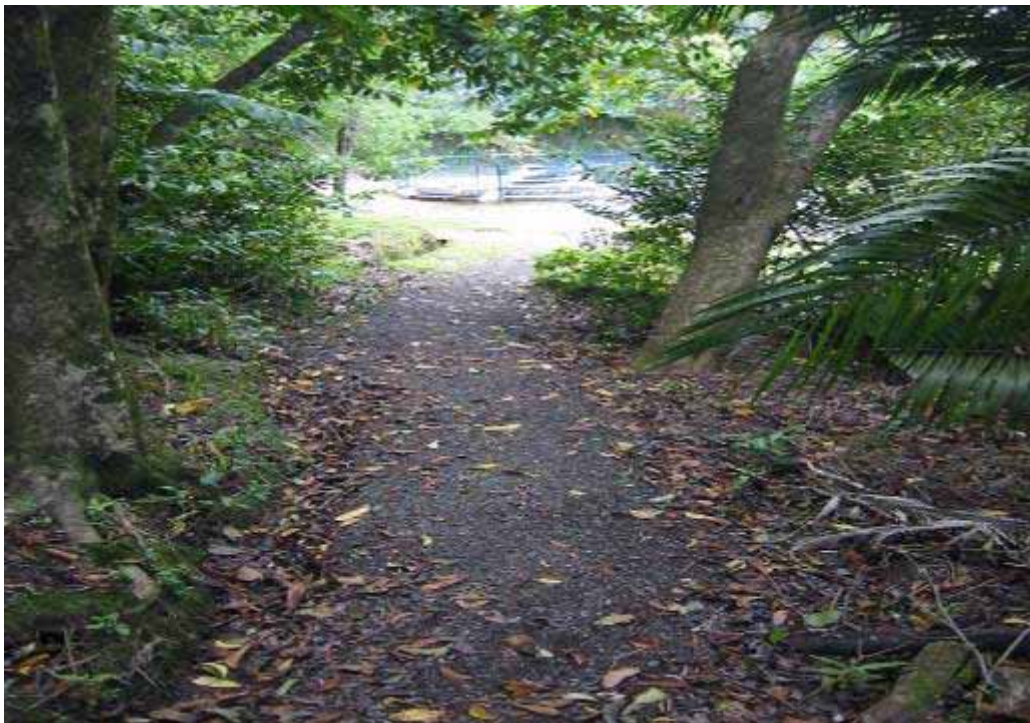
Figure 5: Te Aroha Domain Lower Walk

Te Aroha Domain Lower Walk	
CONDITION	EXISTING
Track Classification	Short Walk
Track Length	673 m
Width Average	.92 m
Grade Average	8.6%
Surface Type	Clay, Gravel
Surface Condition	Minor wear – poor with some problems
Drainage Type	Mono Sloped, Side Drain
Drainage Condition	Minor – poor with some problems
Signage Type	directional
Signage Condition	Minor wear – poor with some problems
Barrier Type	n/a
Barrier Condition	n/a

This track is tar sealed for the first 300 m from the geyser, and passes by points of historic interest.

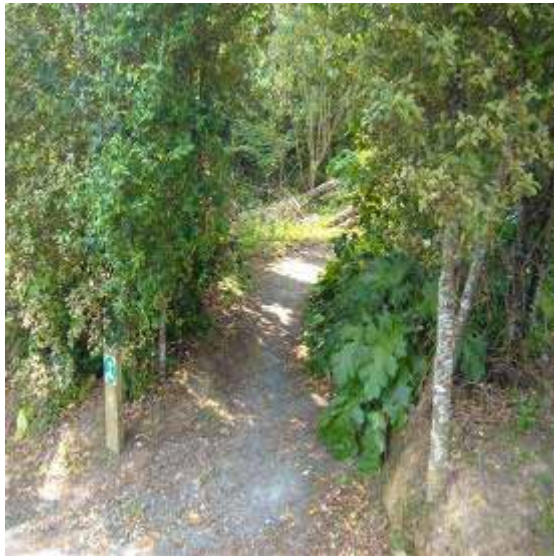
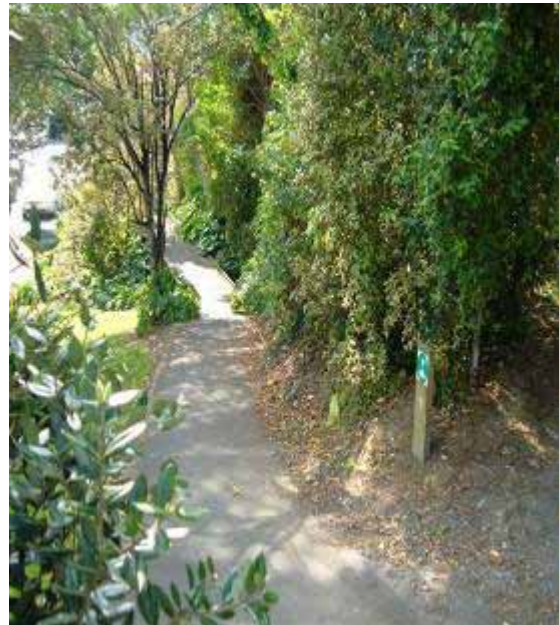
Te Aroha Disabled Geyser Access	
CONDITION	EXISTING
Track Classification	Short Walk
Track Length	81 m
Width Average	2.45 m
Grade Average	12.5%
Surface Type	Aggregate
Surface Condition	Minor wear – poor with some problems
Drainage Type	Mono Sloped
Drainage Condition	Slight collection but functional
Signage Type	Marker
Signage Condition	Showing wear but functional
Barrier Type	n/a
Barrier Condition	n/a

This short track gives access to the Mokena Geyser for people with physical disabilities.

Figure 6 : Existing Geyser Access

Figure 7: Existing Geyser Access

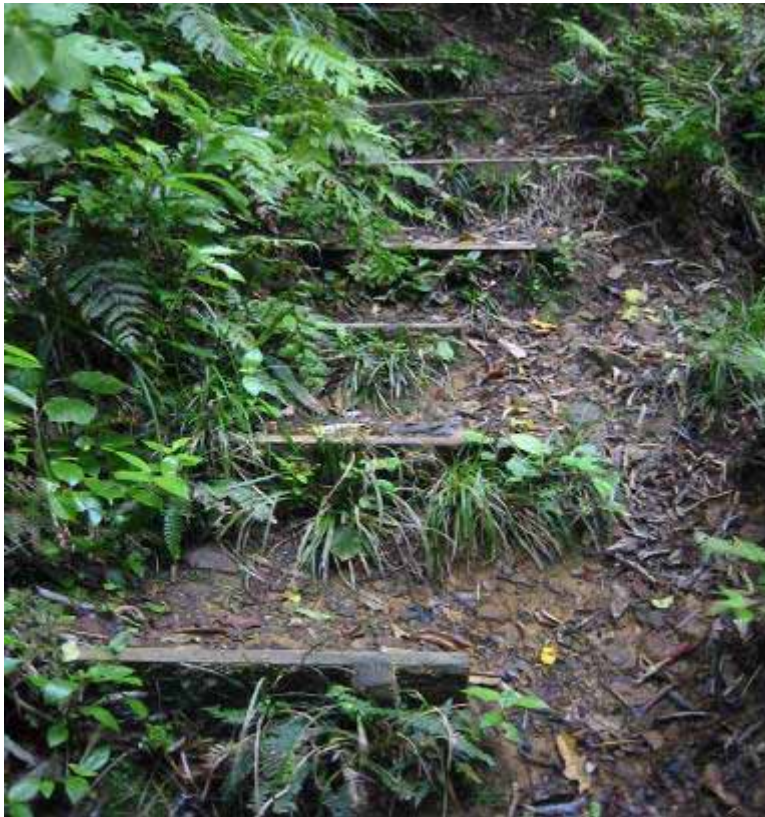
Te Aroha Tui Track	
CONDITION	EXISTING
Track Classification	Walking Track
Track Length	5519 m
Width Average	.95 m
Grade Average	13%
Surface Type	Clay, Gravel, Rock
Surface Condition	Minor wear – poor with some problems
Drainage Type	Mono Sloped, Side Drain, Open Cross Drain, Crowned Track Surface
Drainage Condition	Minor wear – poor with some problems
Signage Type	Directional/ Markers/ Interpretation
Signage Condition	As new – poor with some problems
Barrier Type	Infill 100mm max gap, Rails with 500mm max gap, Top & mid rail, Top rail only
Barrier Condition	Minor wear – very poor

Figure 8: Te Aroha Tui Track – steps

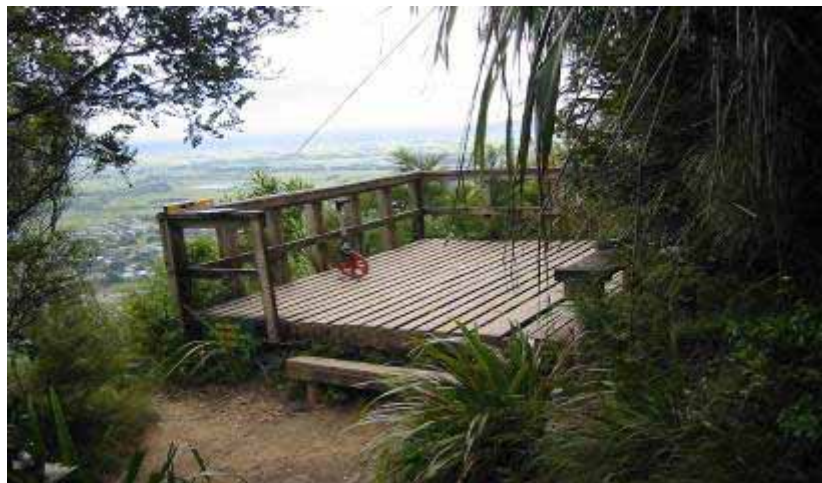
Te Aroha Bald Spur Track	
CONDITION	EXISTING
Track Classification	Walking Track
Track Length	1409 m
Width Average	.96 m
Grade Average	20%
Surface Type	Clay, Gravel
Surface Condition	Showing wear but functional – very muddy or un-even
Drainage Type	Mono Sloped
Drainage Condition	Minor – poor with some problems
Signage Type	Loading (structure)
Signage Condition	Showing wear but functional
Barrier Type	Top & mid rail
Barrier Condition	Showing wear but functional

Figure 10: Te Aroha Bald Spur Track – Look out point

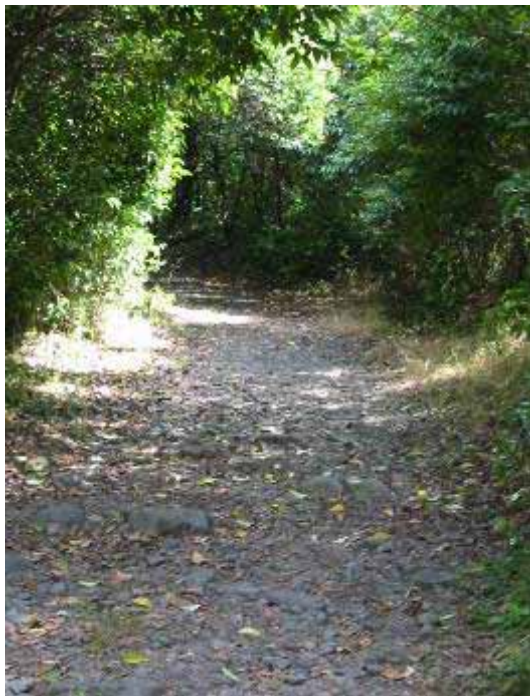
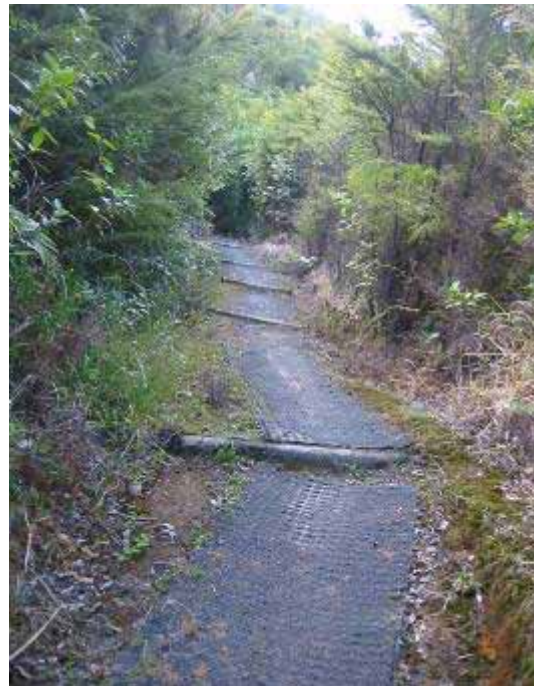
Te Aroha Mountain Bike Track	
CONDITION	EXISTING
Track Classification	Mountain Bike
Track Length	7081 m
Width Average	1.26m
Grade Average	15%
Surface Type	Aggregate, Clay, Structures, Grass
Surface Condition	As new – very muddy or un-even
Drainage Type	Mono Sloped, Crowned track surface, Side Drain
Drainage Condition	Minor – very muddy or un-even
Signage Type	Markers / Directional
Signage Condition	As new – poor with some problems
Barrier Type	Top & mid rail only, top rail only, infill 100mm max gap, Rails with 500mm max gap.
Barrier Condition	Minor wear – poor with some problems

A bike track to suit many levels of ability through a bush setting.

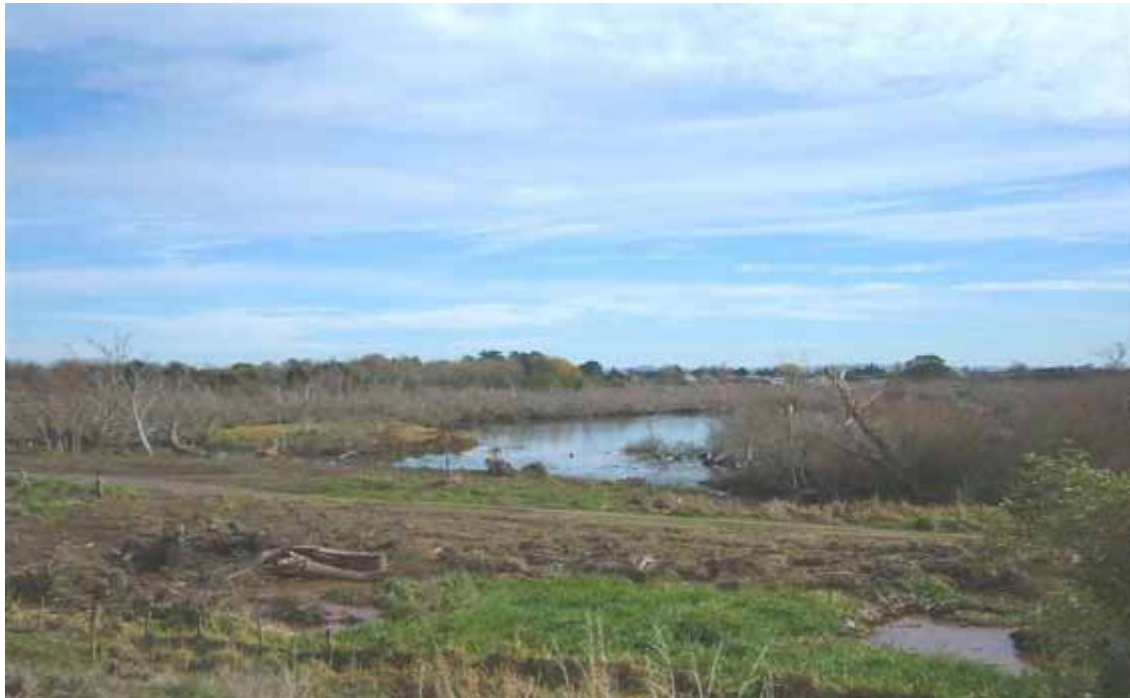
Figure 13: Te Aroha Wetland Walk

Howarth Memorial Wetland Walk	
CONDITION	EXISTING
Track Classification	Short Walk
Track Length	3255 m
Width Average	1.4 m
Grade Average	6.5%
Surface Type	Aggregate, gravel, grass, Clay, structures
Surface Condition	As new – poor with some problems
Drainage Type	Mono Sloped, Crowned, Side Drain
Drainage Condition	Good – poor with some problems
Signage Type	Directional at ends/junctions/interpretation
Signage Condition	As new – poor with some problems
Barrier Type	n/a
Barrier Condition	n/a

A one hour return walk on mainly level surface, passing through an attractive wildlife refuge.

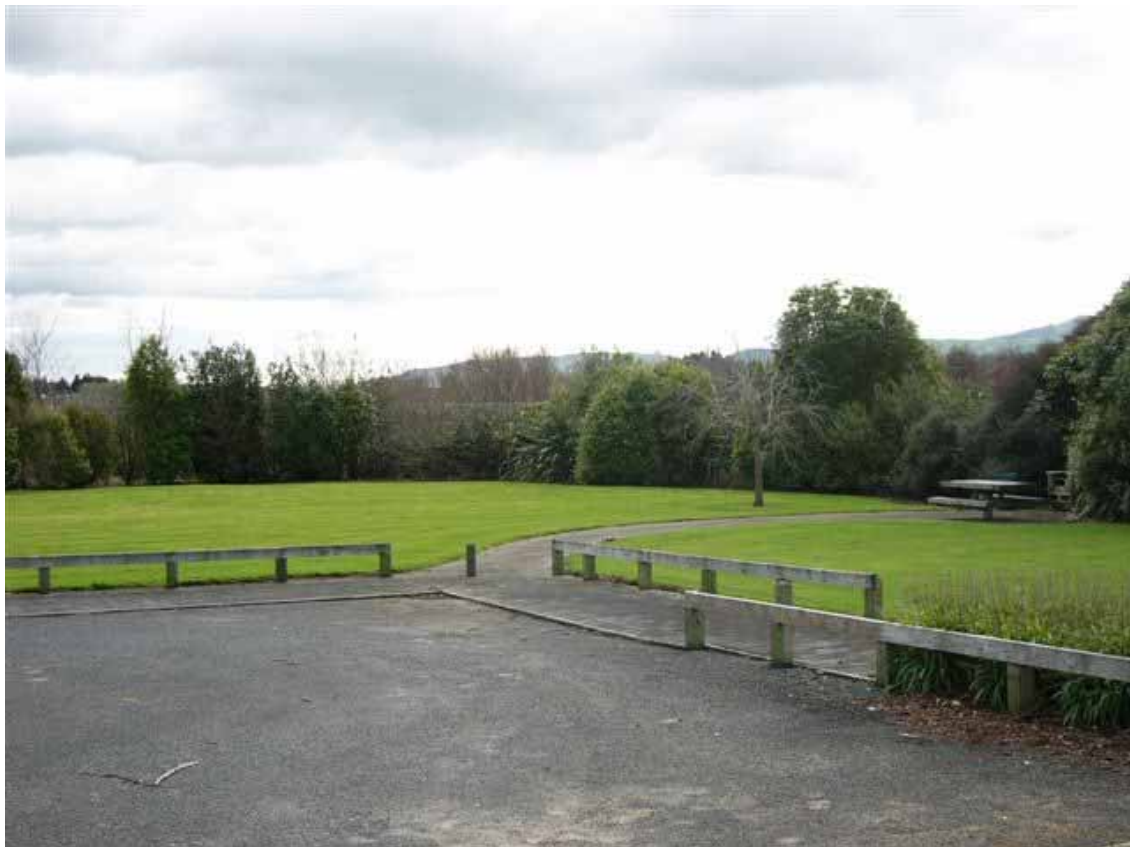
Figure 14: Kenwyn Reserve Link to Wetlands Reserve

Kenwyn Reserve Link to Wetland Reserve	
CONDITION	EXISTING
Track Classification	Short Walk
Track Length	40m
Width Average	1.3m
Grade Average	37% (steps)
Surface Type	Aggregate, Timber, Cobblestones
Surface Condition	As new
Drainage Type	Crowned
Drainage Condition	Minor
Signage Type	None
Signage Condition	n/a
Barrier Type	Handrail (steps)
Barrier Condition	n/a

The link is a boardwalk / box stepped walkway from Kenwyn Reserve to the Railway Embankment giving access to the Wetlands Reserve.

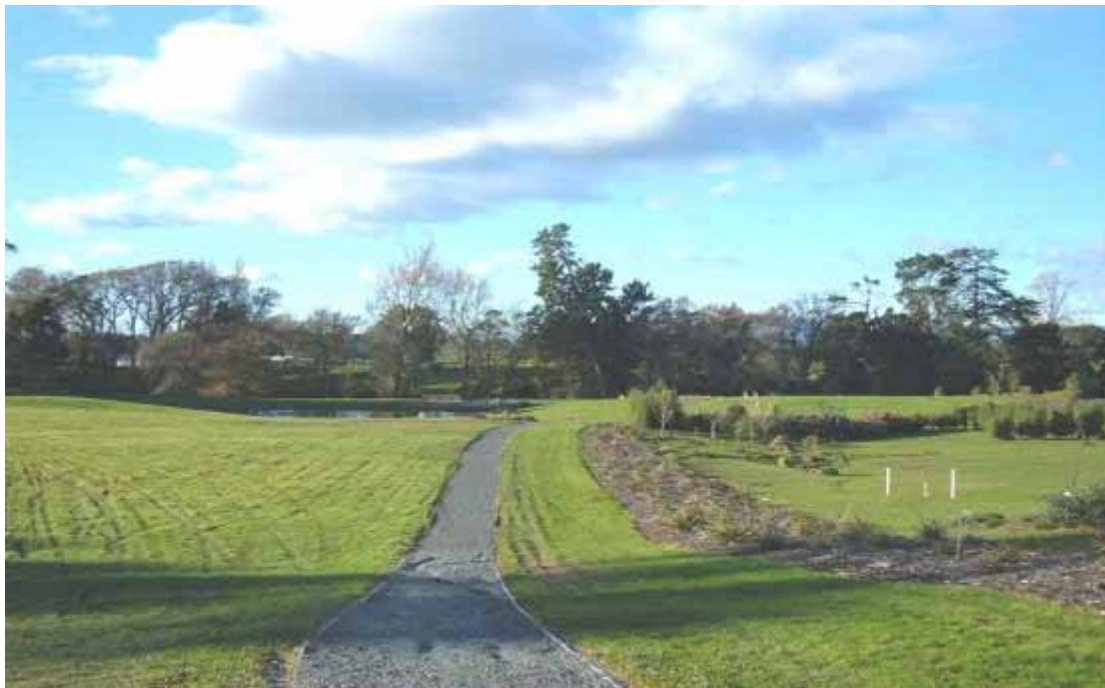
Figure 15: Morrinsville Holmwood Park Walk

Morrinsville Holmwood Park Walk	
CONDITION	EXISTING
Track Classification	Path
Track Length	1291 m
Width Average	1.36 m
Grade Average	13%
Surface Type	Aggregate, Clay, structures
Surface Condition	Showing wear but functional
Drainage Type	Mono Sloped
Drainage Condition	Slight collection but functional
Signage Type	n/a
Signage Condition	As new – poor with some problems
Barrier Type	Some present
Barrier Condition	Poor with some problems

A pleasant River walk from Holmwood Park housing subdivision.

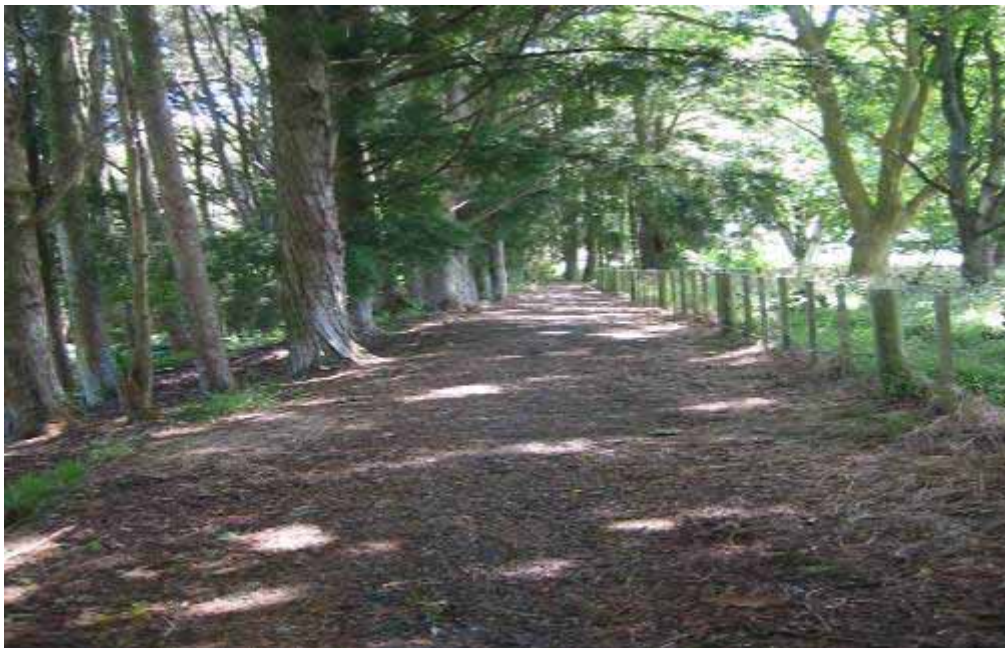
Figure 16: Morrinsville River Walk

Morrinsville River Walk	
CONDITION	EXISTING
Track Classification	Path
Track Length	1825 m
Width Average	1.23 m
Grade Average	23%
Surface Type	Aggregate, Clay, structures
Surface Condition	Showing wear but functional – very muddy or un-even
Drainage Type	Mono Sloped
Drainage Condition	Slight collection but functional
Signage Type	Some markers
Signage Condition	As new – poor with some problems
Barrier Type	Some present
Barrier Condition	Very poor

A pleasant river walk passing along the rear of the Morrinsville Recreational Ground. Stands of mature native trees present.

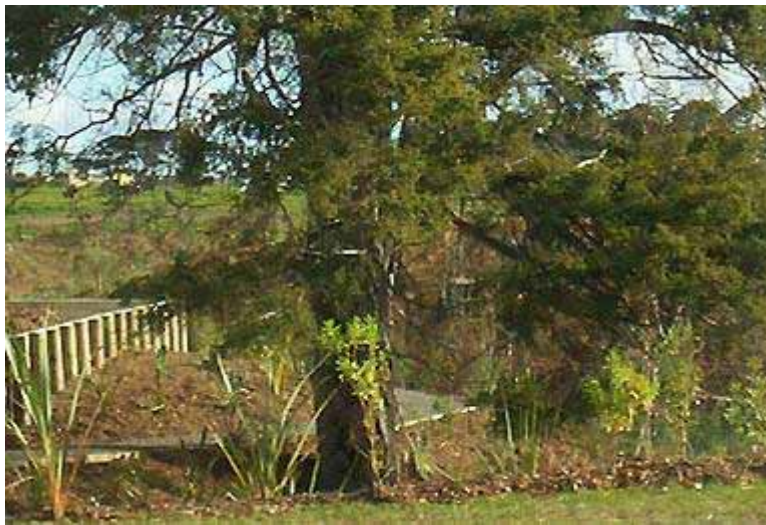
Figure 19: Parklands Walkway

Morrinsville Parklands Walkway	
CONDITION	EXISTING
Track Classification	Path
Track Length	570 m
Width Average	1.4 m
Grade Average	2%
Surface Type	Aggregate, Concrete
Surface Condition	As new – minor wear
Drainage Type	Mono Sloped, Crowned
Drainage Condition	Good - Minor
Signage Type	n/a
Signage Condition	n/a
Barrier Type	n/a
Barrier Condition	n/a

This walkway links several streets within the Parklands Subdivision and follows the stream edge.

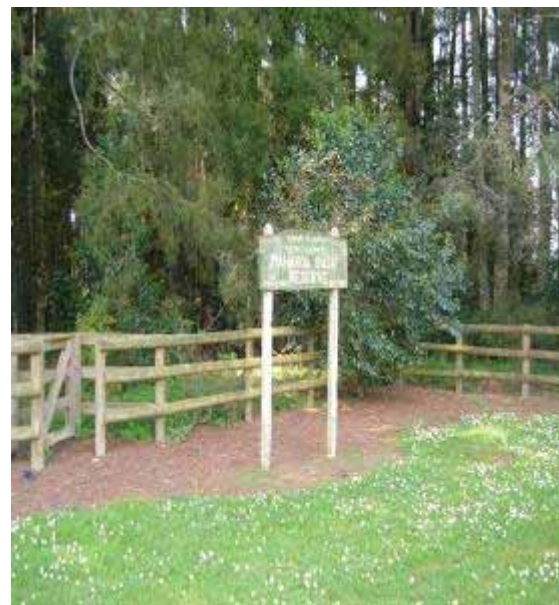
Waharoa Hawes Bush Walk	
CONDITION	EXISTING
Track Classification	Walking Track
Track Length	400 m
Width Average	1 m
Grade Average	2%
Surface Type	Clay, Gravel, Grass
Surface Condition	Showing wear but functional – very muddy or un-even
Drainage Type	n/a
Drainage Condition	n/a
Signage Type	Intersection, Interpretation
Signage Condition	Showing wear but functional – poor with some problems
Barrier Type	n/a
Barrier Condition	n/a

Figure 21: The main entrance to Hawes Bush Walk

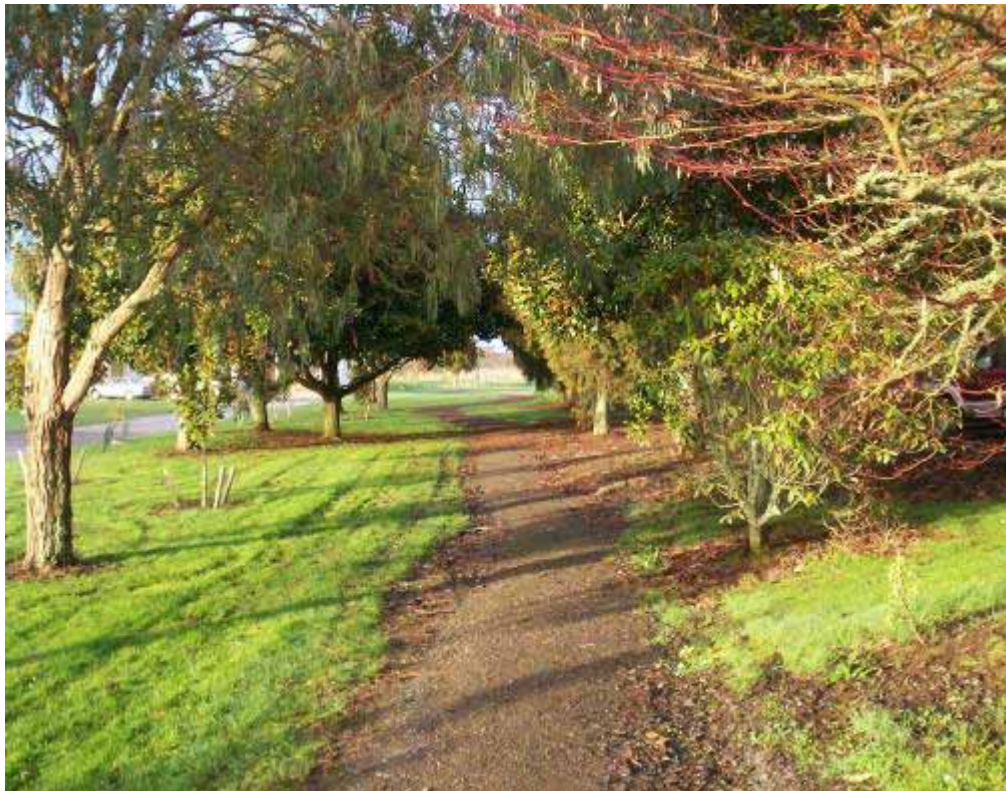
Figure 22 : Matamata Neil Agar / Furness Park Walkway

Matamata Neil Agar / Furness Park Walkway	
CONDITION	EXISTING
Track Classification	Short walk
Track Length	550m
Width Average	1.2m
Grade Average	2%
Surface Type	Gravel, Clay,
Surface Condition	As new – showing wear but functional
Drainage Type	Mono Sloped,
Drainage Condition	Showing wear but functional – poor with some problems
Signage Type	Interpretation
Signage Condition	n/a
Barrier Type	n/a
Barrier Condition	n/a

This pleasant walk on flat ground links Furness Reserve and provides an ideal walking experience for an aged population and people with limited physical abilities.

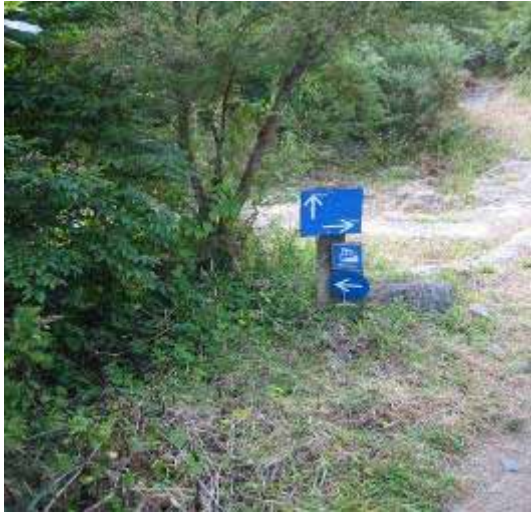
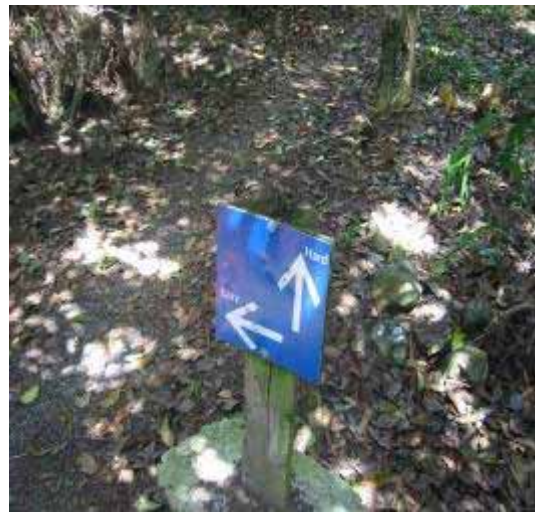
Current track signage along the district's network is not of a uniform standard or format. The signs are of a basic informal nature. Most do not identify the track as being owned and maintained by MPDC and show limited information, such as direction and name of track. Examples of existing signs are shown in figures (19) to (20). MPDC intends to develop a signage strategy to resolve the current signage issues, as discussed in Section 5.3 "Proposed Signage Strategy".

Figure 23: Mountain Bike Track signage

Figure 24: Mountain Bike Track signage

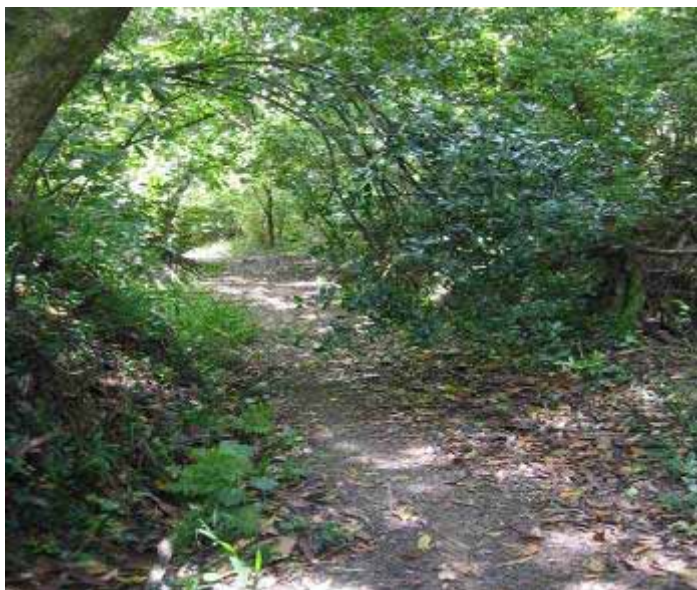
**Upgrade comments:
Upgrade completed
February '08**

- Increase average track width to 2m maximum
- Upgrade surface type to durable well drained surface, suitable for all footwear
- Upgrade track drainage
- New directional signs at entrances / junctions highlighting the points of interest

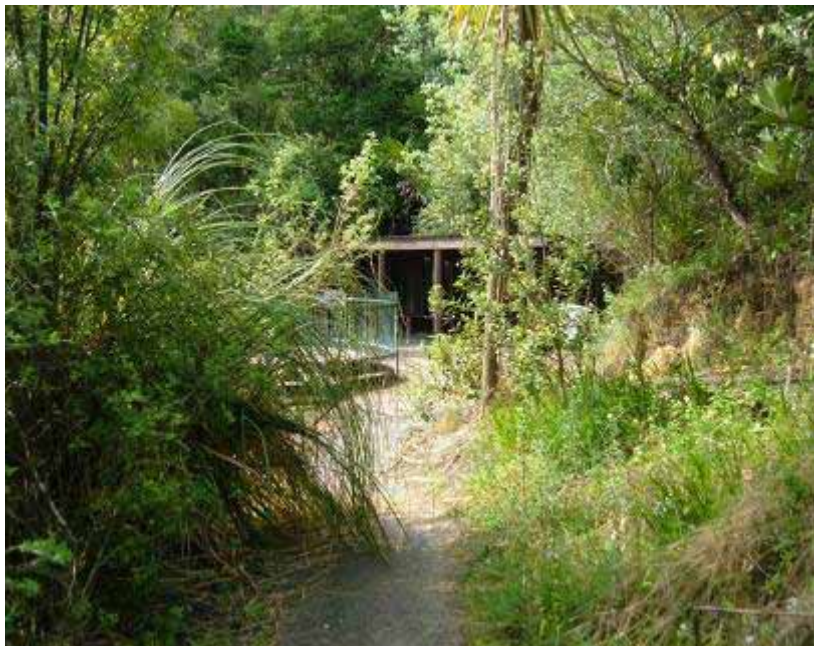
Figure 28: Te Aroha Geyser access

CONDITION	EXISTING	PROPOSED
Track Classification	Short Walk	Path
Track Length	81 m	81 m
Width Average	2.45 m	1.5 m
Grade Average	12.5%	Max. 12.5%
Surface Type	Aggregate	Durable, paved surface of concrete / chip seal / asphalt or well bound aggregate
Surface Condition	Minor wear – poor with some problems	As new – minor wear
Drainage Type	Mono Sloped	Well drained free from ponded surface water
Drainage Condition	Slight collection but still functional	As new – minor
Signage Type	Marker	All entrances and junctions to have directional signs
Signage Condition	Showing wear but still functional	As new – minor wear
Barrier Type	n/a	Guardrail/Barrier where a significant hazard exists
Barrier Condition	n/a	As new – minor wear.

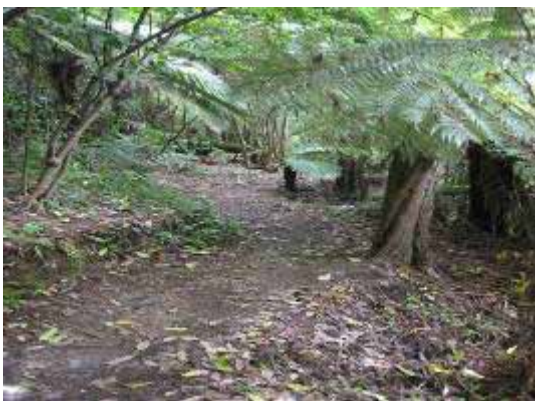
Figure 29: Te Aroha Tui Track

CONDITION	EXISTING	PROPOSED
Track Classification	Walking Track	Walking Track
Track Length	5519 m	5519 m
Width Average	.95 m	.75 m min. 2 m max
Grade Average	13%	Max. 7%
Surface Type	Clay, Gravel, Rock	Mostly well formed and even, wet areas drained. In dry weather able to walk comfortably in light walking boots
Surface Condition	Minor wear – very muddy or un-even	As new – showing wear but still functional
Drainage Type	Mono Sloped, Side Drain, Open Cross Drain, Crowned Track Surface	Crowned track surface with associated site works
Drainage Condition	Minor – ponding with little or no soakage	As new – minor wear
Signage Type	Directional/Markers/Interpretation	Directional at entrances/junctions. Significant points of interest
Signage Condition	As new – poor with some problems	As new – minor wear
Barrier Type	Infill 100mm max gap, Rails with 500mm max gap, Top & mid rail, Top rail only	Guardrail/Barrier where a significant hazard exists to inexperienced visitors

Barrier Condition	Minor wear – very worn	As new – minor wear

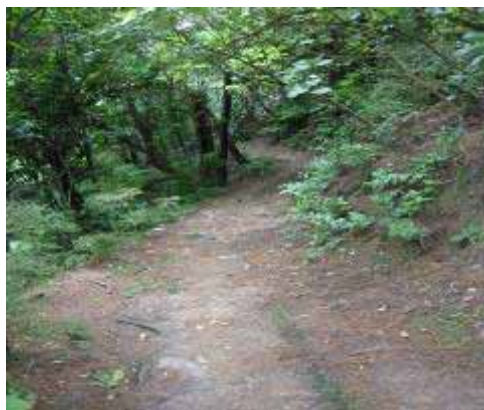
Figure 30: Te Aroha Bald Spur Track

CONDITION	EXISTING	PROPOSED
Track Classification	Walking Track	Walking Track
Track Length	1409 m	1409 m
Width Average	.96 m	.75 m min. 2 m max
Grade Average	20%	Max. 15%
Surface Type	Clay, Gravel	Mostly well formed and even, wet areas drained. In dry weather able to walk comfortably in light walking boots
Surface Condition	Showing wear but functional – very muddy or un-even	As new – showing wear but functional
Drainage Type	Mono Sloped	Crowned track surface mono slope with 3% cross flow
Drainage Condition	Minor wear – poor with some problems	As new – minor wear
Signage Type	Loading (structure)	Directional at entrances /junctions, showing both walking times & distances
Signage Condition	Showing wear but functional	As new – minor wear
Barrier Type	Top & mid rail	Guardrail/Barrier where a significant hazard exists to the predominant visitor group
Barrier Condition	Showing wear but functional	As new – minor wear

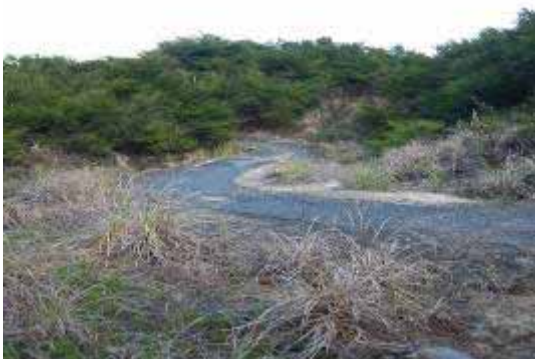
Figure 31: Te Aroha Mountain Bike Track

Barrier Type	Top & mid rail only, top rail only, infill 100mm max gap, Rails with 500mm max gap	Significant falls & hazards immediately adjacent to the track to have a barrier provided at the fall edge.
Barrier Condition	n/a	As new – minor wear

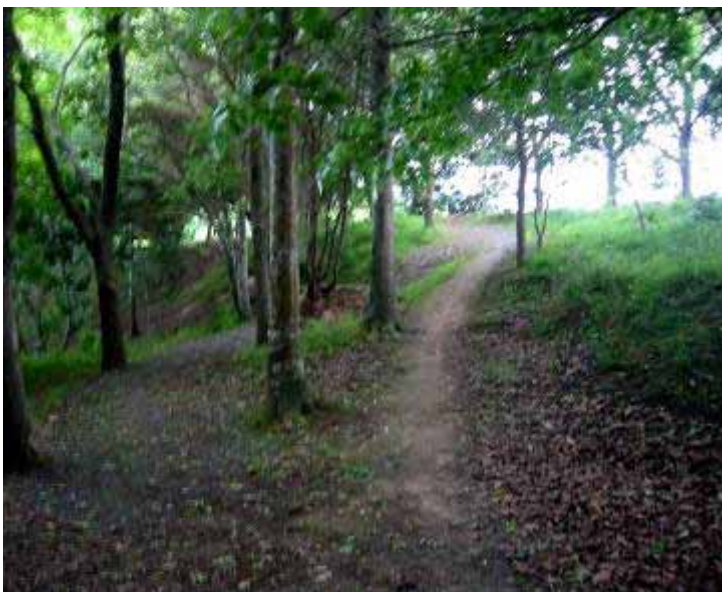
Figure 32: Te Aroha Wetland Walk

CONDITION	EXISTING	PROPOSED
Track Classification	Short Walk	Short Walk
Track Length	3255 m	3255 m
Width Average	1.4 m	1.4 m min. 2 m max
Grade Average	6.5%	Max. 10%
Surface Type	Aggregate, gravel, grass, Clay, structures	Durable, well drained, suitable for all types of footwear
Surface Condition	As new – poor with some problems	As new – showing wear but functional
Drainage Type	Mono Sloped, Crowned, Side Drain	Crowned track surface with associated site works
Drainage Condition	As new – poor with some problems	As new - minor
Signage Type	Directional at ends/junctions/interpretation	Directional at entrances/junctions, significant points of interest
Signage Condition	As new – showing wear but functional	As new – minor wear
Barrier Type	n/a	Guardrail/Barrier where a significant hazard exists to inexperienced visitors.
Barrier Condition	n/a	As new – minor wear

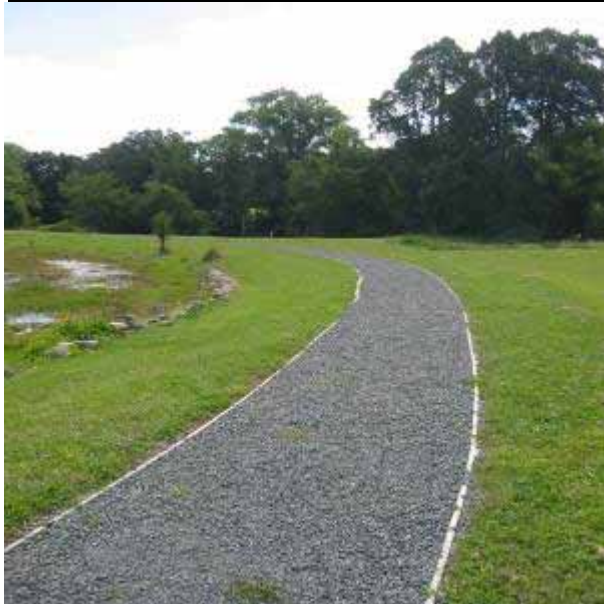
Figure 33: Morrinsville Holmwood Park Walk

CONDITION	EXISTING	PROPOSED
Track Classification	Path	Short Walk
Track Length	1291 m	1,291m
Width Average	1.36 m	.75 m min. 2 m max
Grade Average	13%	Max. 10%
Surface Type	Aggregate, Clay, structures	Durable, well drained, suitable for all types of footwear
Surface Condition	Showing wear but functional	As new – showing wear but functional
Drainage Type	Mono Sloped	Crowned track surface with associated site works
Drainage Condition	Slight collection but functional	As new - minor
Signage Type	n/a	Directional at entrances / junctions, significant points of interest
Signage Condition	As new – poor with some problems	As new – minor wear
Barrier Type	Some present	Guardrail/Barrier where a significant hazard exists to inexperienced visitors
Barrier Condition	Poor with some problems	As new – minor wear

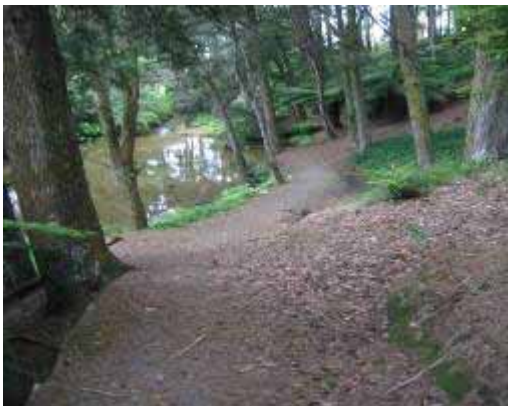
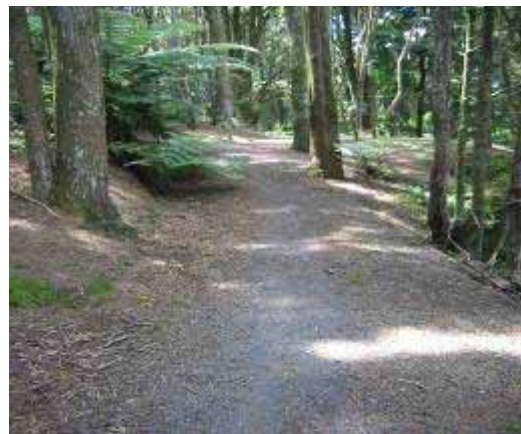
Figure 34: Morrinsville River Walk

Figure 35 Morrinsville River Walk

- Reduce average grade to maximum 10%
- Upgrade track surface
- Upgrade of directional / significant point of interest signs
- Barrier upgrade required

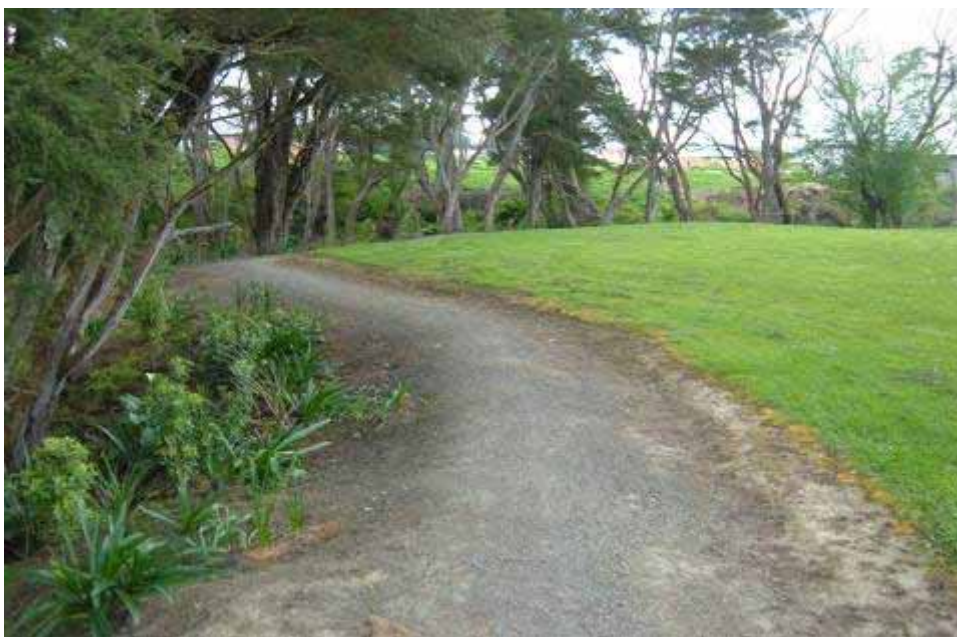
Figure 36: Lockerbie Park Walkway – part with a gravel surface

- The upgrading to a path classification will give uniformity to the two different styles of walkways currently present.

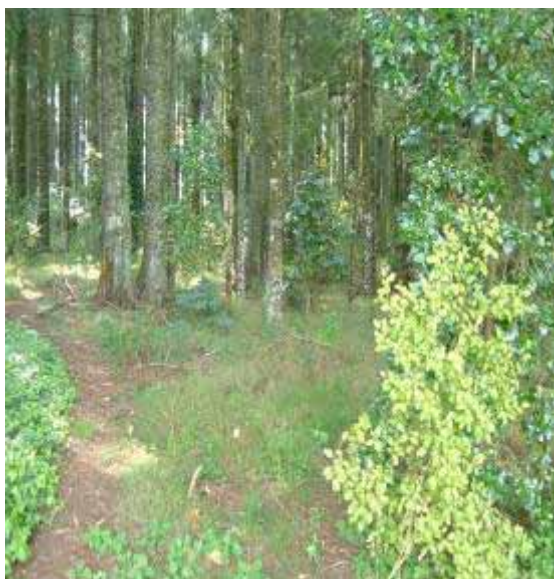
CONDITION	EXISTING	PROPOSED
Track Classification	Walking Track	Short Walk
Track Length	400m	400m
Width Average	1 m	.75 m min. 2 m max
Grade Average	2%	10% max
Surface Type	Clay, Gravel, Grass	Durable, paved surface of concrete / chip seal / asphalt or well bound aggregate
Surface Condition	Showing wear but functional – very muddy or un-even	As new – showing wear but functional
Drainage Type	n/a	As new – minor wear
Drainage Condition	n/a	As new – minor wear
Signage Type	Intersection	Directional at entrances / junctions, significant points of interest
Signage Condition	Showing wear but functional – poor with some problems	As new – minor wear
Barrier Type	n/a	Guardrail / barrier where a significant hazard exists to inexperienced visitors.
Barrier Condition	n/a	As new – minor wear

Figure 38 : Hawes Bush Walk showing tracks and unclear paths

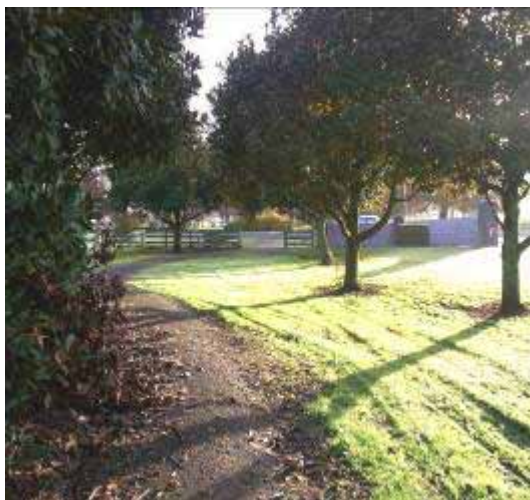
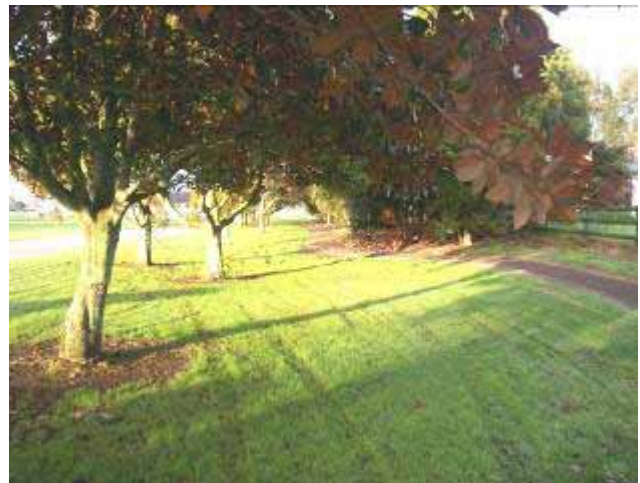
Figure 39: Neil Algar / Furness Park Walkway

Figure 40: Neil Algar / Furness Park Walkway

- Install path in boundary around Furness Park and link to Neil Algar walk via footbridge
- Directional signage at all junctions and entrance
- **Neil Algar walk completed February ' 08**

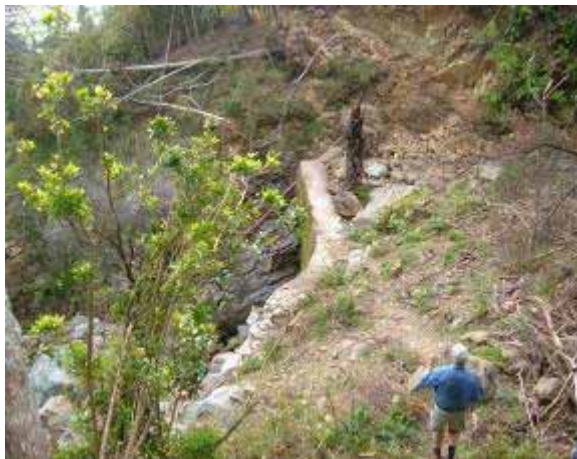
Figure 41: Proposed Horseman's Track

The track would start at the saddle behind Bald Spur. The hidden 'Horseman's Track', descends on the north side into the Tutumangeao Valley on a formed 1m wide bench. This is followed for approximately 560m until the formation is lost due to early erosion. Through this part there will need to be some vegetation clearance and light spade work on the actual path. An added attraction to the Horseman's track is that halfway down it there is an old goldmine.

From the Horseman's track termination, a reasonable route to form a path down to the Tutumangeao stream, a distance of approximately 250 metres. The track then crosses the Tutumangeao stream at the dam. This dam has formed a very attractive waterfall.

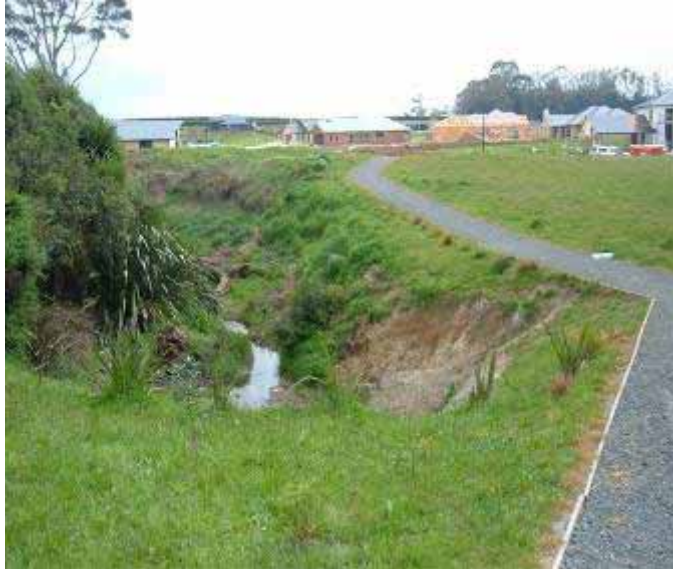
Figure 44: Proposed Lockerbie Park walkway

This proposed series of walkways links together Coronation Road, Stirling Drive South, Willow Grove, George Street, Stirling Drive and Coppa Crescent. A Concrete pathway from George Street to Willow Grove already exists.

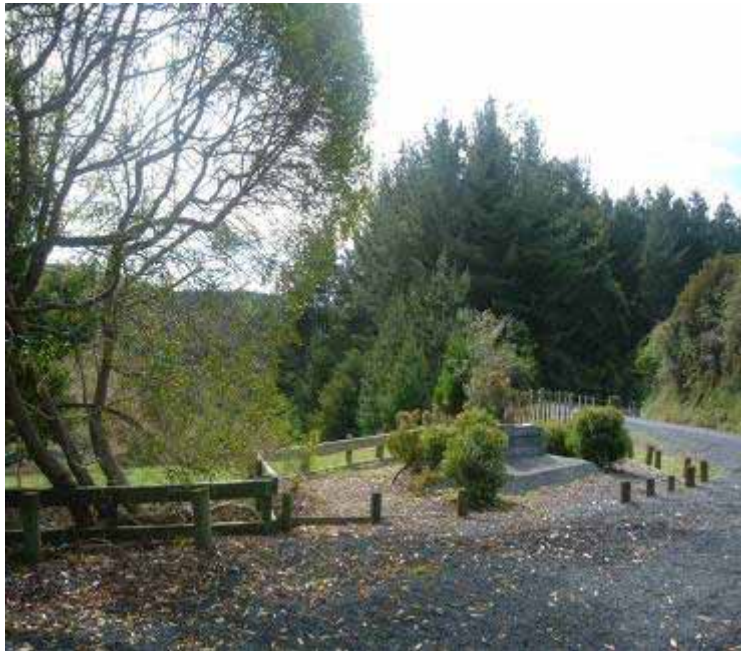
Figure 46: Proposed Morrinsville Mountain Bike Track

Within the Morrinsville Waterworks catchments area is an existing network of mountain bike tracks and walkways.

Over the last four years these tracks have deteriorated due to the pine forest logging operations and the reduction in use by mountain bikers, due to illegal use of off road motorcycles.

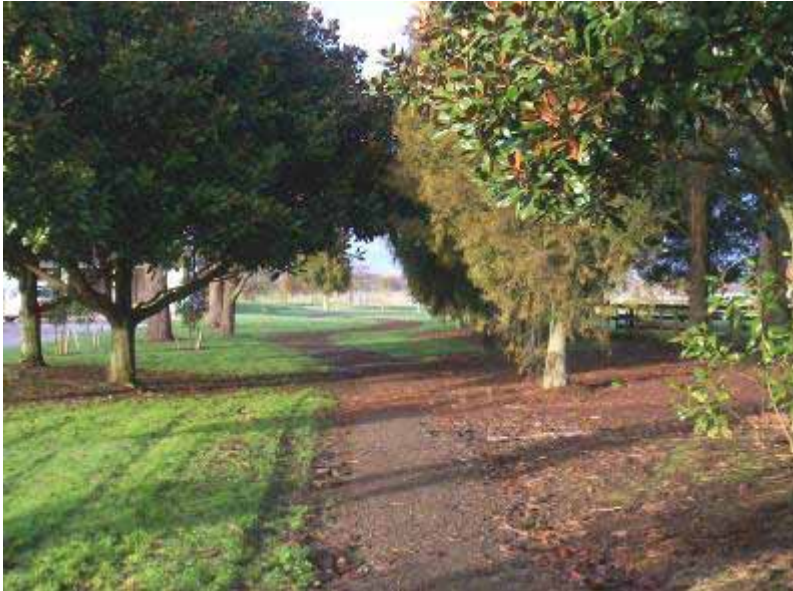
Figure 48 : Proposed Neil Algar / Furness Park Walkway - stage 1 path

This proposed series of walkways links together Peria Road with Pohlen Park via the Neil Algar Reserve. The walkway around Furness Park Reserve is linked to the Neil Algar walkway via a footbridge over a boundary drain.

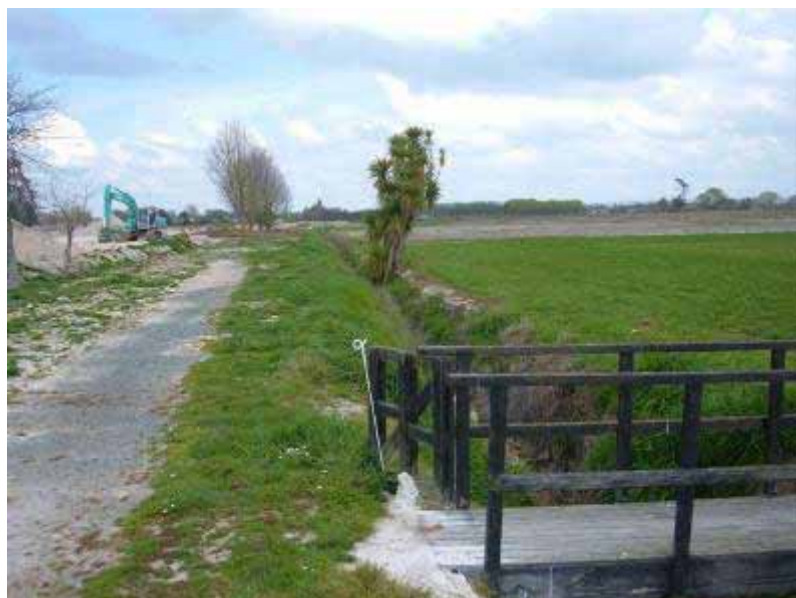
Figure 49: A footbridge over a boundary drain.
