# **Appendix D**

## **Proposed Minor Improvements to State Highway 27**

### **Hinuera Road Intersection**

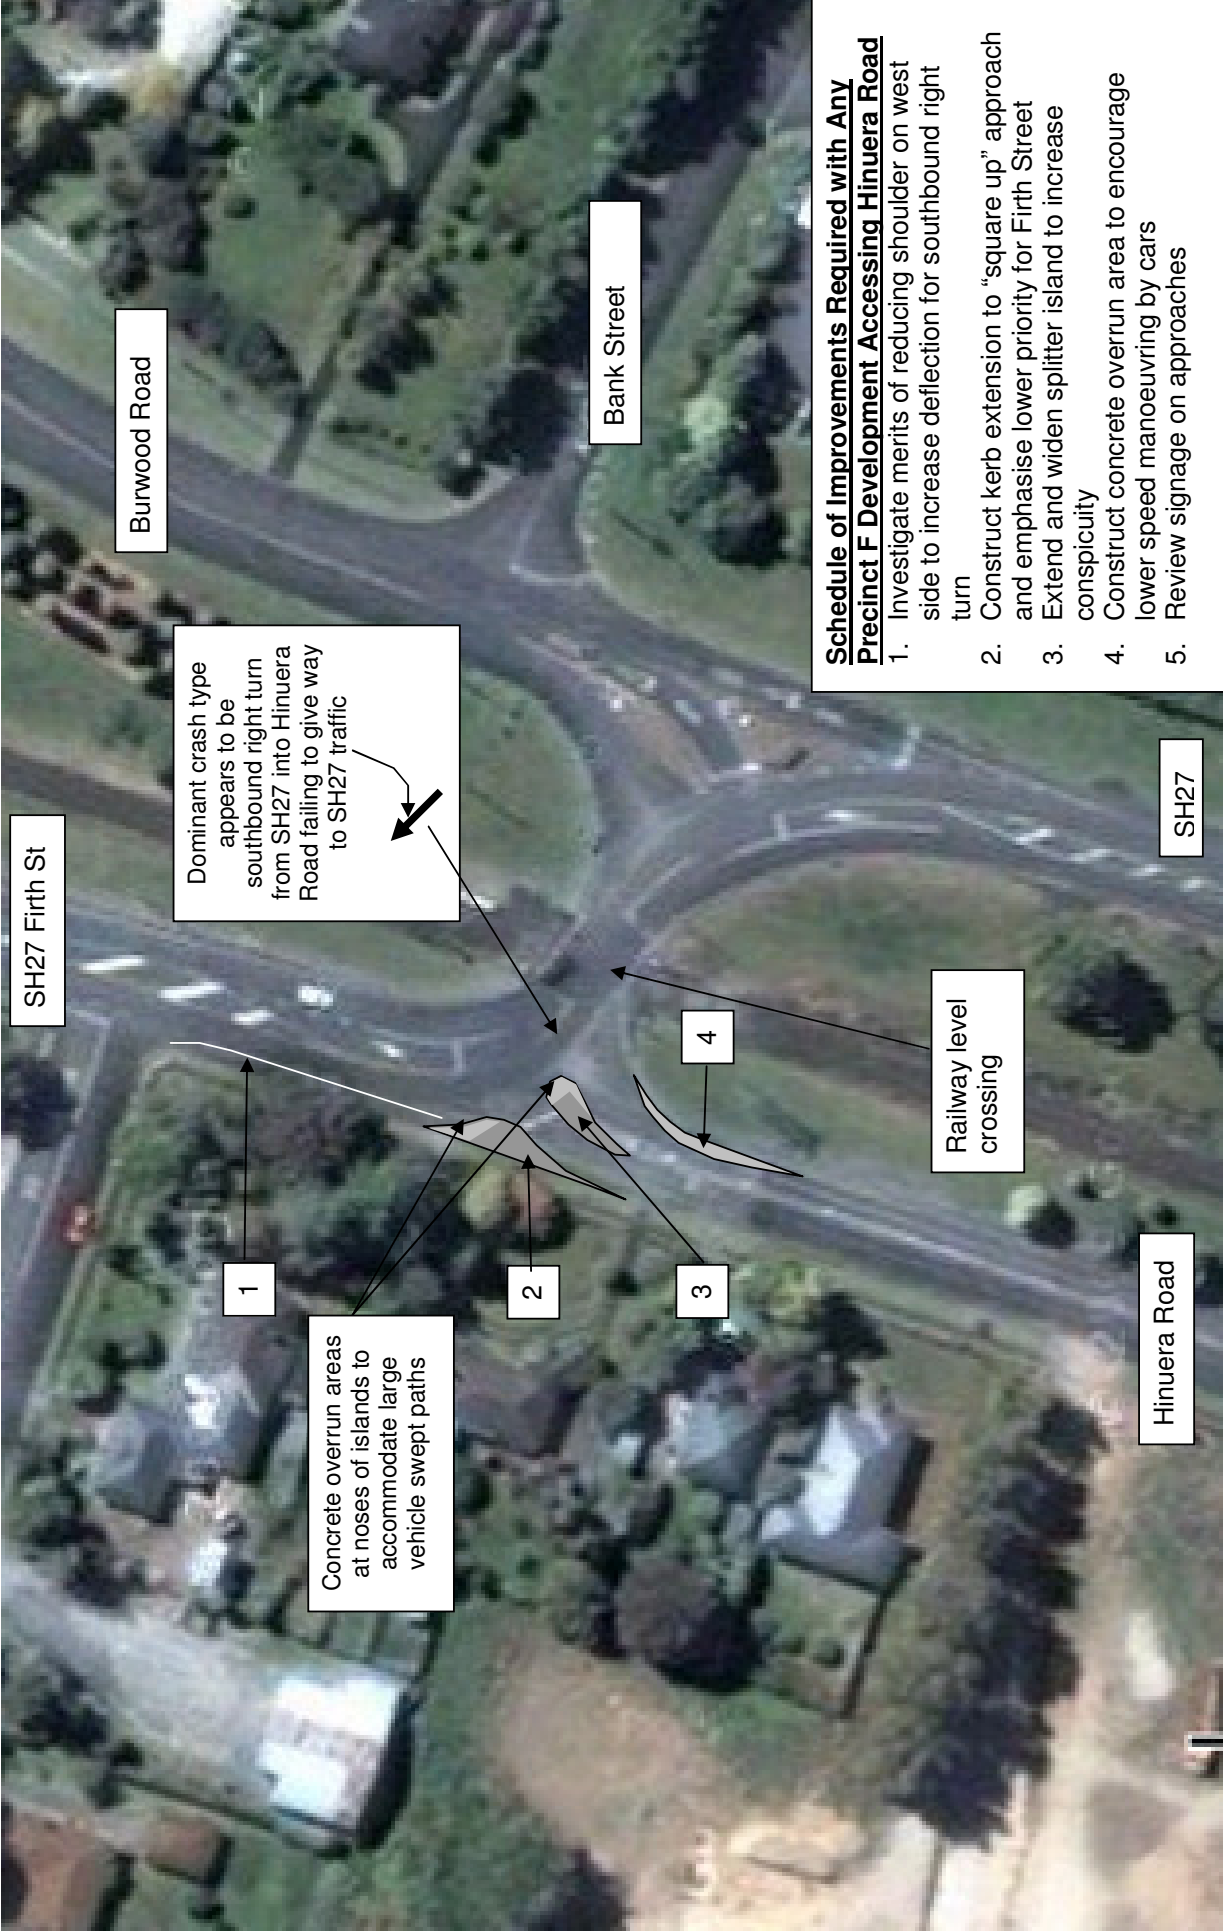
Dominant crash type appears to be southbound right turn from SH27 into Hinuera Road failing to give way to SH27 traffic

Concrete overrun areas at noses of islands to accommodate large vehicle swept paths

**Schedule of Improvements Required with Any Precinct F Development Accessing Hinuera Road**

1. Investigate merits of reducing shoulder on west side to increase deflection for southbound right turn
2. Construct kerb extension to "square up" approach and emphasise lower priority for Firth Street
3. Extend and widen splitter island to increase conspicuity
4. Construct concrete overrun area to encourage lower speed manoeuvring by cars
5. Review signage on approaches
